State Water Resources Control Board
Order 6/14/2021

Term 2 and 4 - Fisheries Monitoring Tasks

**Sonoma
Water**

April 8, 2022

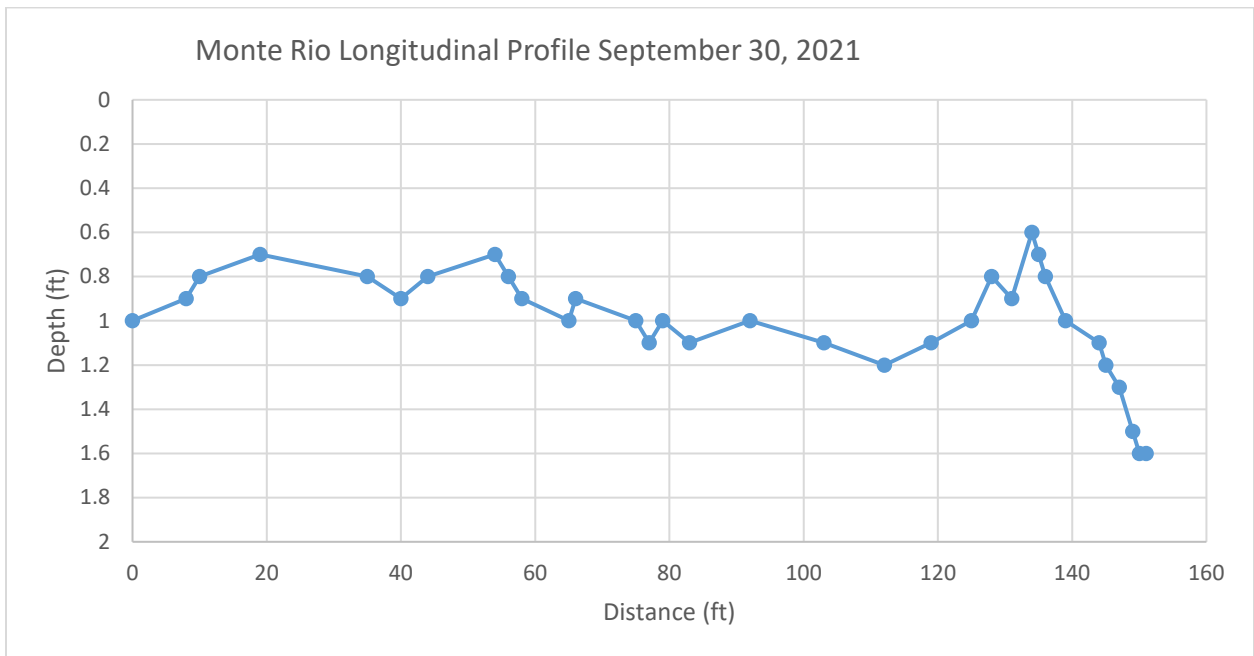
Figure 27. Longitudinal profile depths at Monte Rio on September 30, 2021. Flow at the USGS Hacienda stream gage (gage number 11467000) was 45 cfs.

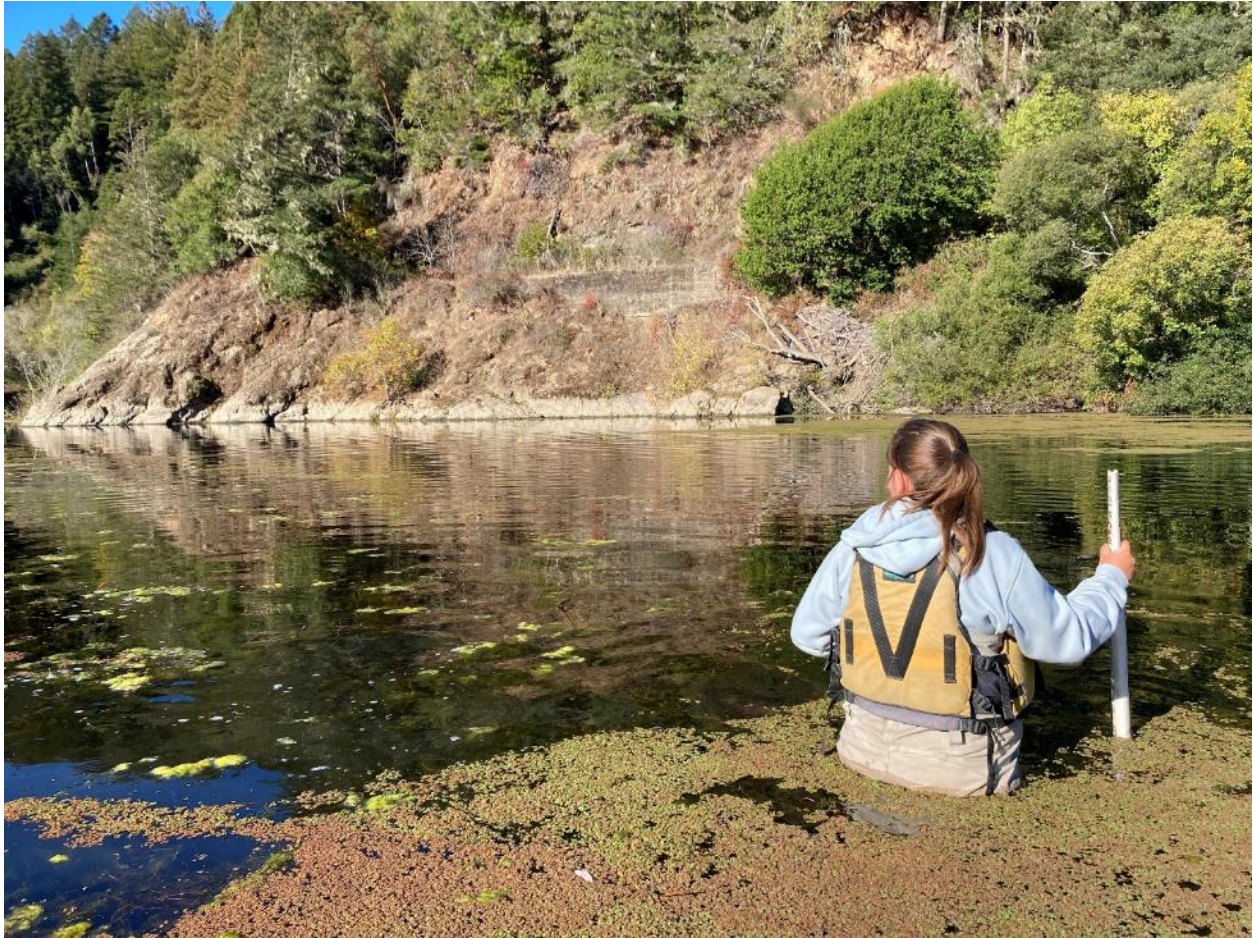
Figure A 10. Brown's riffle located near the confluence with Austin Creek on September 30, 2021 showing inundation from the ponding effect when the mouth of the Russian River closed. Flow at the USGS Hacienda stream gage (gage number 11467000) was 45 cfs.
