**RE: Reporting Requirements for Term 7 of the State Water Resources Control Board
Order 2021-0056-EXEC (June 14, 2021)**

Term 7 - Fisheries Monitoring Summary Report

April 8, 2022

Sonoma County Water Agency

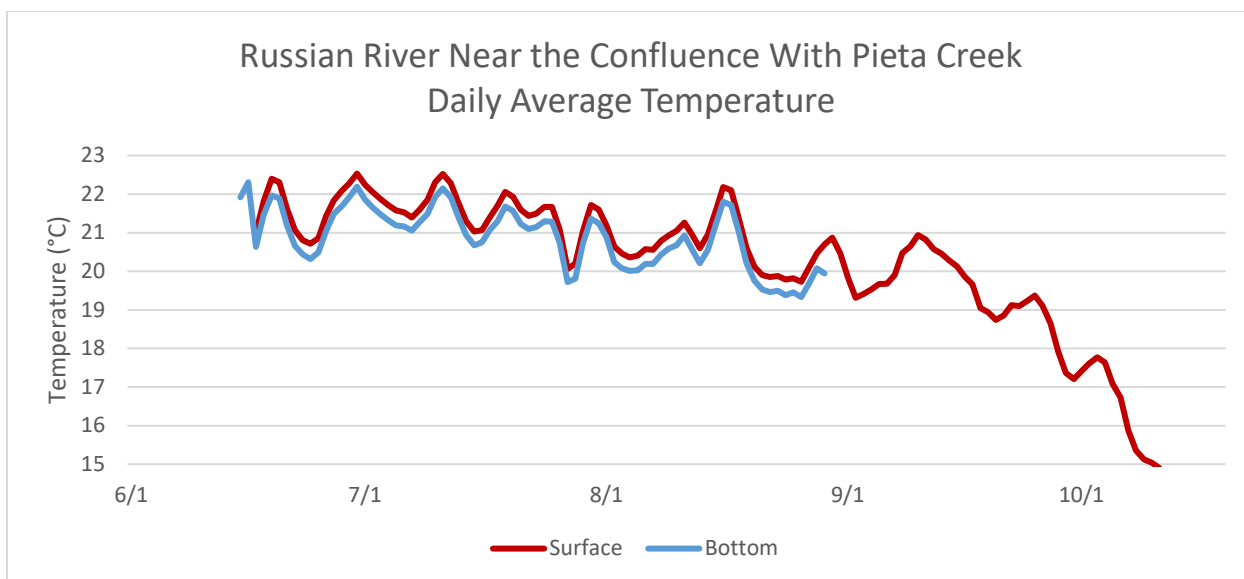
On June 15, and June 16, 2021 we measured water temperature at visited seven sites, two of which had temperature stratification. We deployed continuous water temperature monitoring arrays at four sites in order to evaluate temperature stratification. Three of these water quality arrays included continuous measurements of dissolved oxygen. Sites were at the mouth of Pieta Creek near Hopland, downstream of Leaping Lady Rock near Hopland, the old Highway 101 crossing near Preston, and at Del Rio Woods County Park near Healdsburg (Figure 15). We had planned to put a water temperature monitoring array at Commisky Station. However, after diving that site we chose not to, as the pools were shallow and not stratified. Water quality loggers were recovered on October 20, 2021. The surface water quality sonde at Del Rio Woods was not recovered. While there was some stratification in pools sampled, the vertical temperature differential was minimal (Figure 16- Figure 19).

Figure 16. Daily Average temperature from water quality loggers deployed at Del Rio Woods (rKm 57.8).

Figure 17. Daily average temperature from water quality loggers deployed at Geysers Road (rKm 107.0).

Figure 18. Daily average temperature from water quality loggers deployed downstream of Leaping Lady Rock (rKm 118.1).

Figure 19. Daily average temperature from water quality loggers deployed in the Russian River at the confluence with Pieta Creek (rKm 120.4).

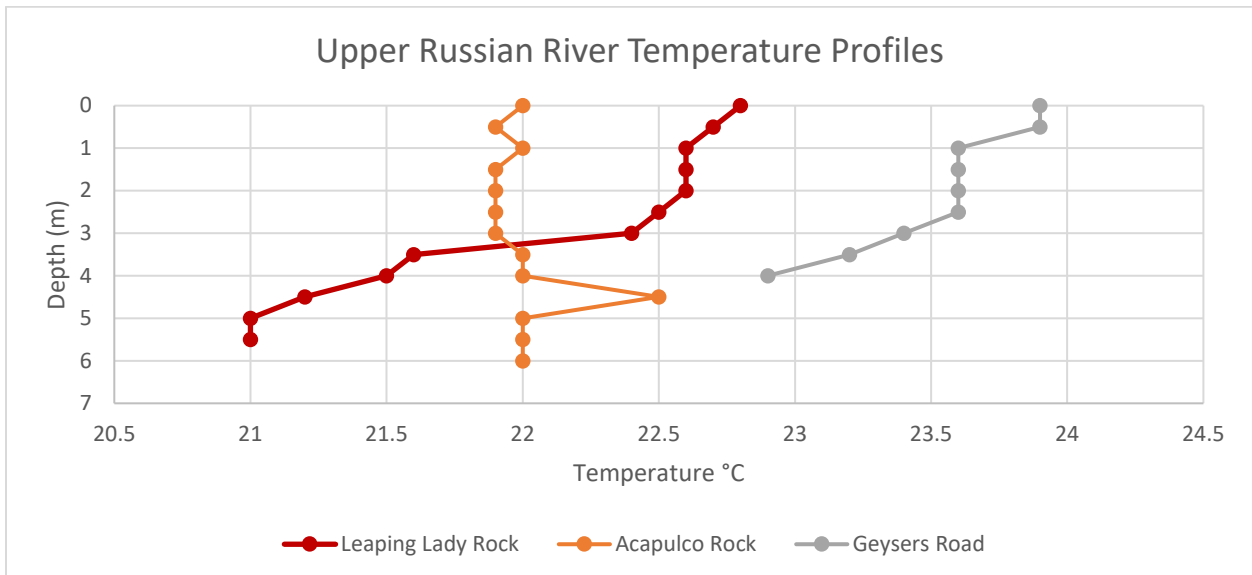
During the week of July 18, 2021 water quality profiles were taken in a pool downstream of Leaping Lady Rock near Hopland, in a pool downstream of the confluence of Pieta Creek at Acapulco Rock, and in a pool at the old Highway 101 crossing off Geysers Road near Preston (Figure 13). Temperature ranged from 21.0°C to 23.9°C depending on the site and depth sampled. Water temperature was weakly stratified at all sites except Acapulco Rock (Figure 23). Dissolved oxygen ranged from 7.8 mg/l to 9.72 mg/L (Figure 24).

Figure 23. Water temperature profiles for a pool downstream of Leaping Lady Rock near Hopland, downstream of the confluence of Pieta Creek at Acapulco Rock, at the old Highway 101 crossing off Geysers Road near Preston, and at Hacienda Bridge near Forestville. Profiles were taken during the week of July 18, 2021.

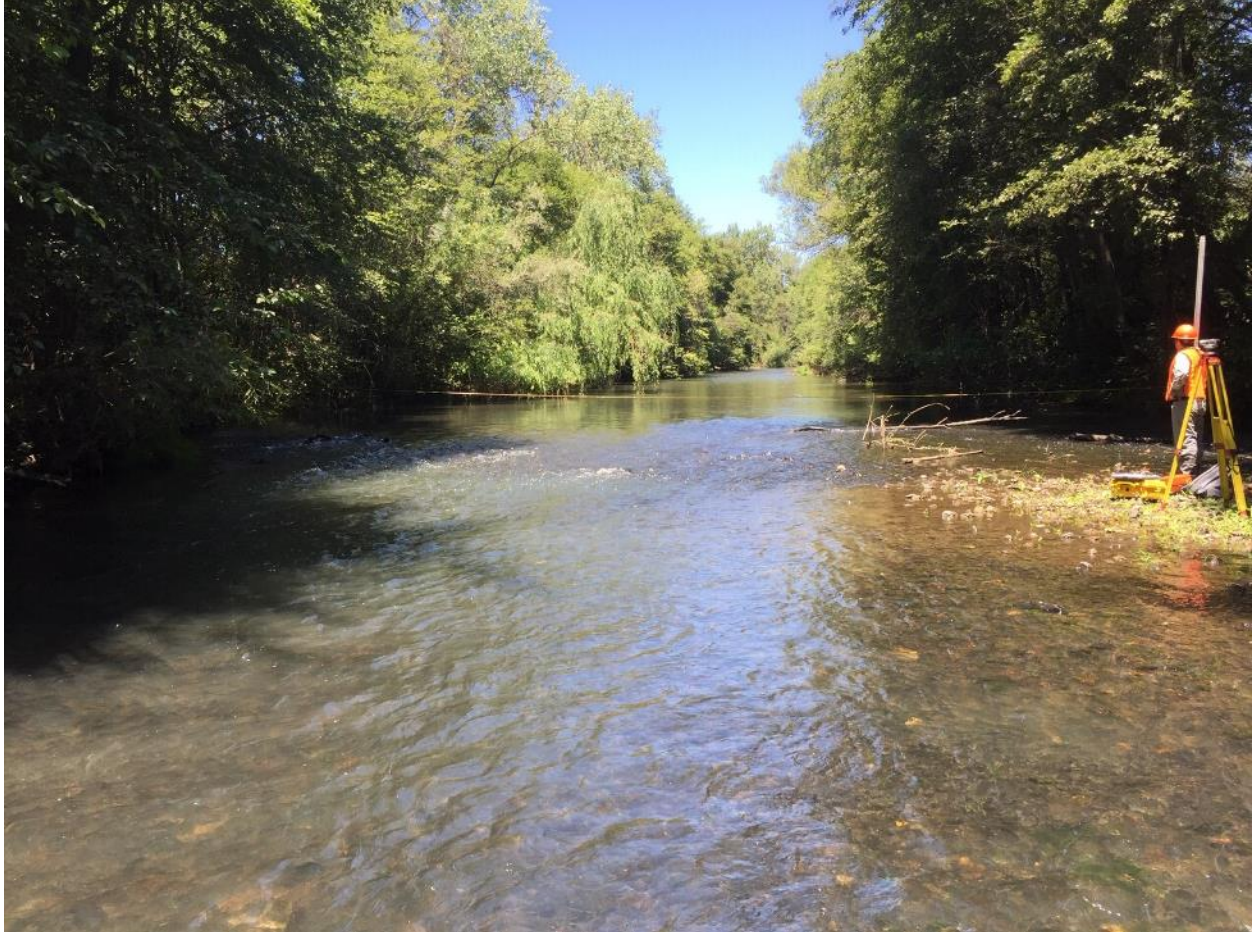
Figure A 1. A photo of the Ukiah sample site on the mainstem Russian River (rkm 158.89) taken on June 13, 2021 when flow was 74 cfs. Flow is the combination of the release from Coyote Valley dam and the flow in the west fork of the Russian River (USGS gage number 11461000).

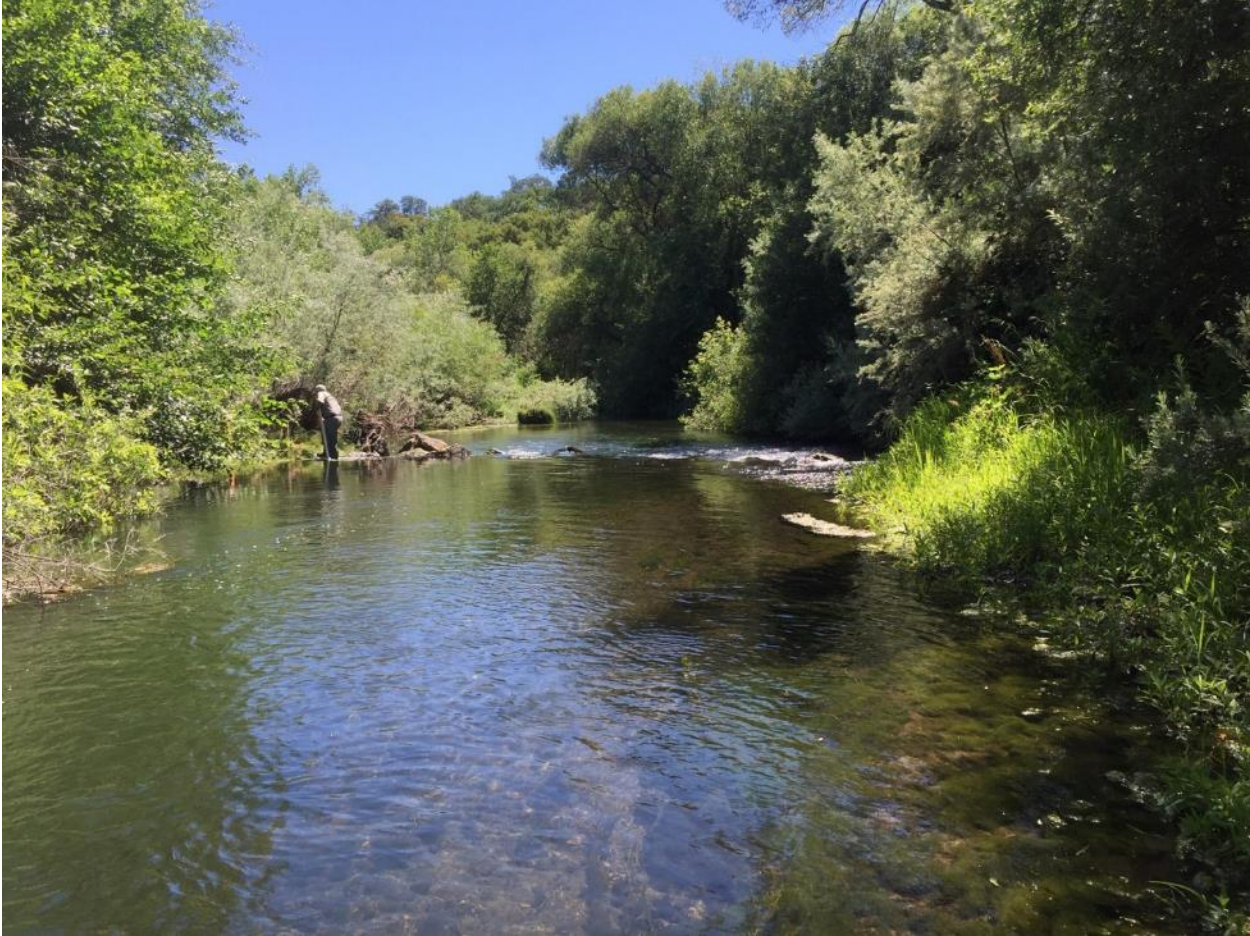
Figure A 2. A photo of the Hopland sample site on the mainstem Russian River (rkm 137.97) taken on June 13, 2021 when flow was 53 cfs. Flow is from the USGS Hopland stream gage (gage number 11462500).

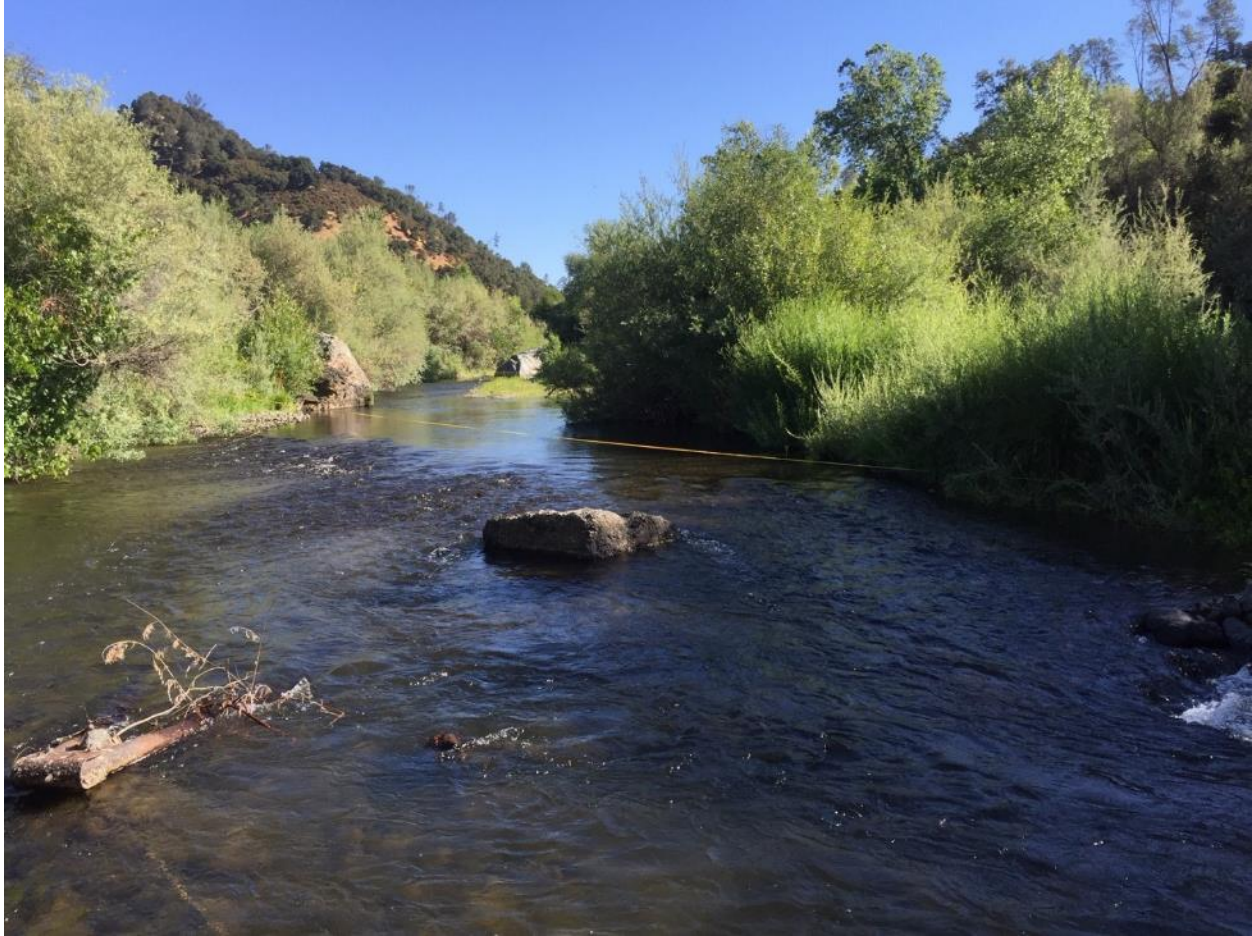
Figure A 3. A photo of the Comminsky Station sample site on the mainstem Russian River (rkm 114.67) taken on June 13, 2021 when flow was 58 cfs. Discharge is from the USGS Cloverdale stream gage (gage number 11463000).

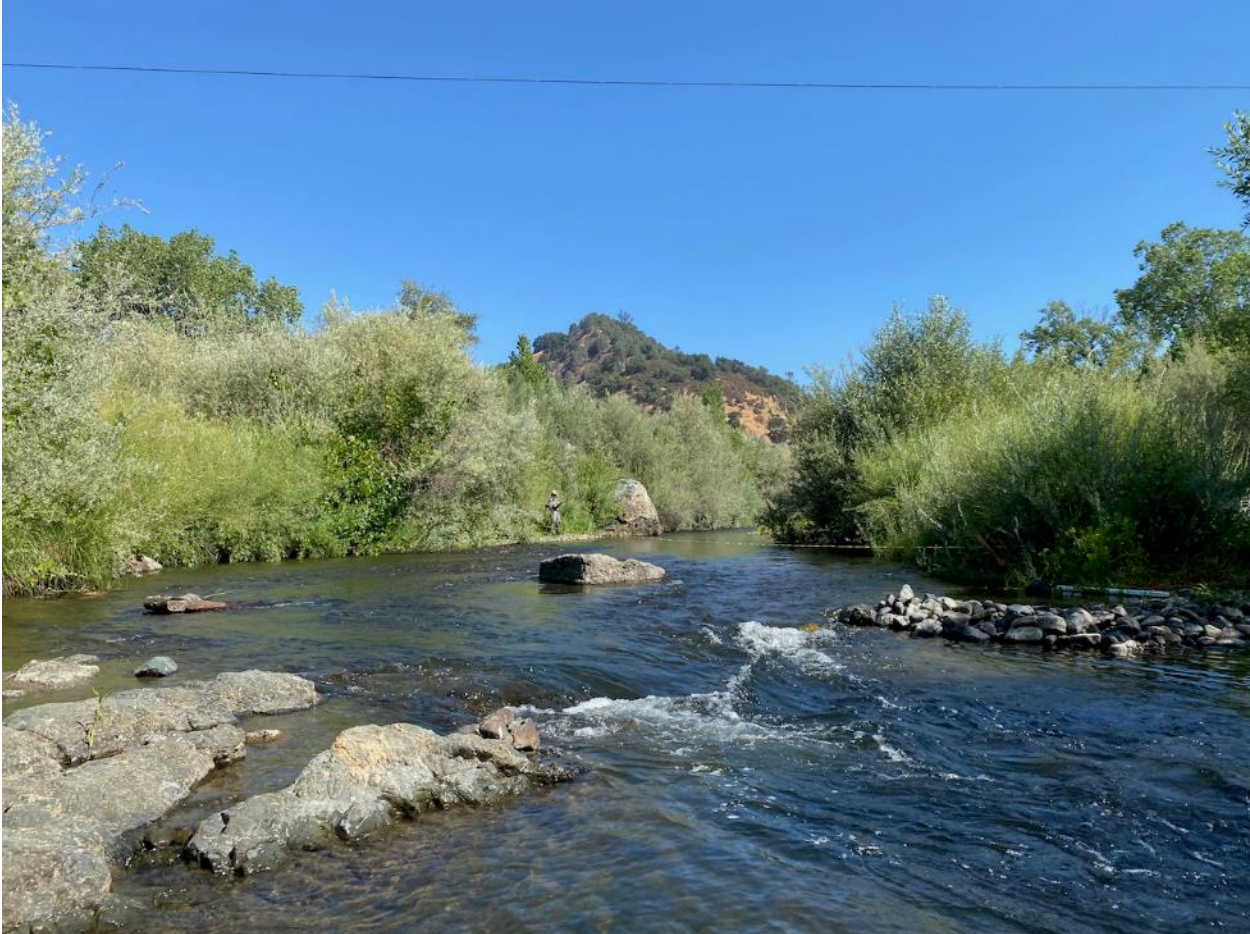
Figure A 4. A Photo of the Comminsky Station sample site on the mainstem Russian River (rkm 114.67) taken on July 12, 2021 when flow was 63 cfs. Discharge is from the USGS Cloverdale stream gage (gage number 11463000).

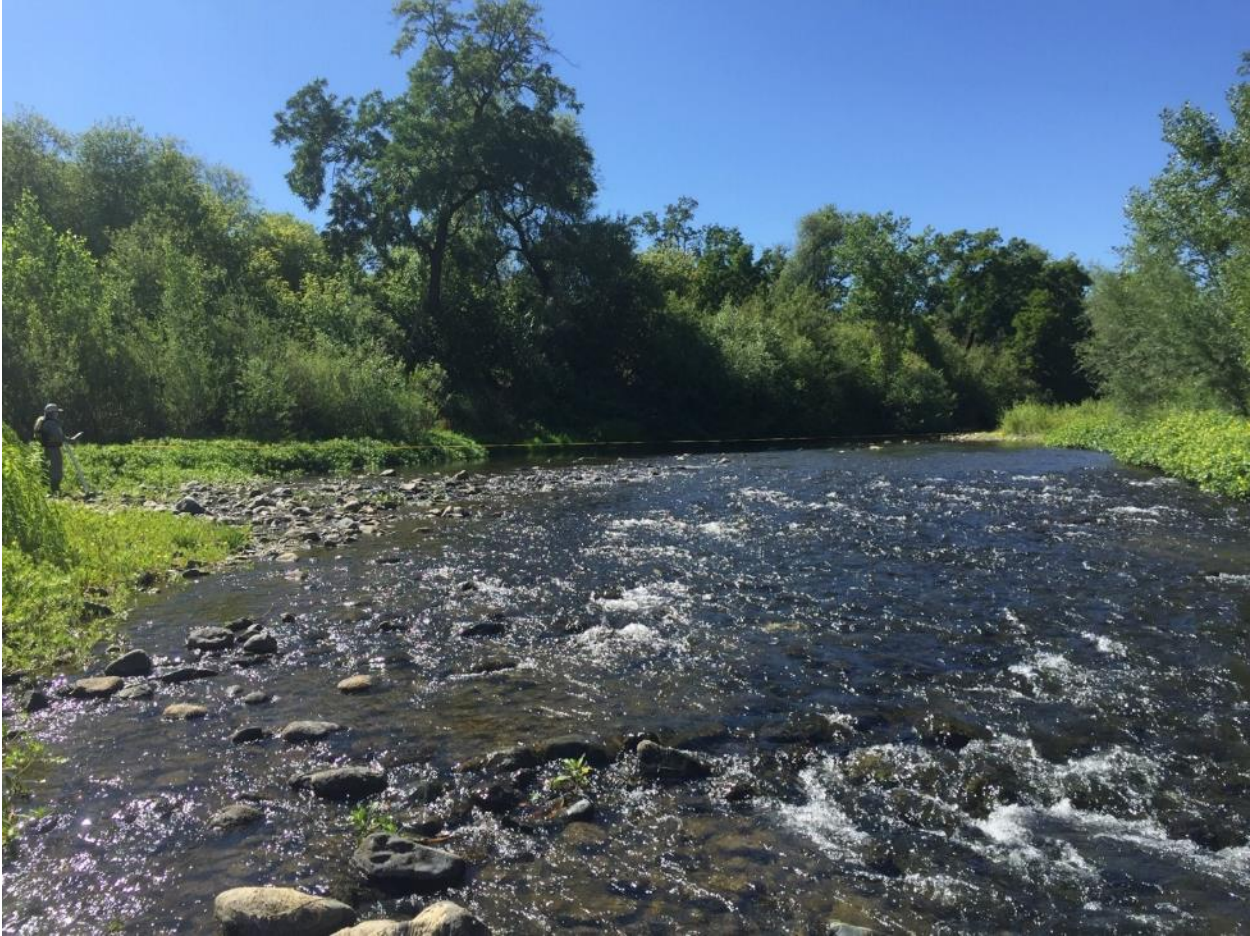
Figure A 5. A photo of the Cloverdale sample site on the mainstem Russian River (rkm 104.61) taken on June 13, 2021 when flow was 60 cfs. Discharge is from the USGS Cloverdale stream gage (gage number 11463000).

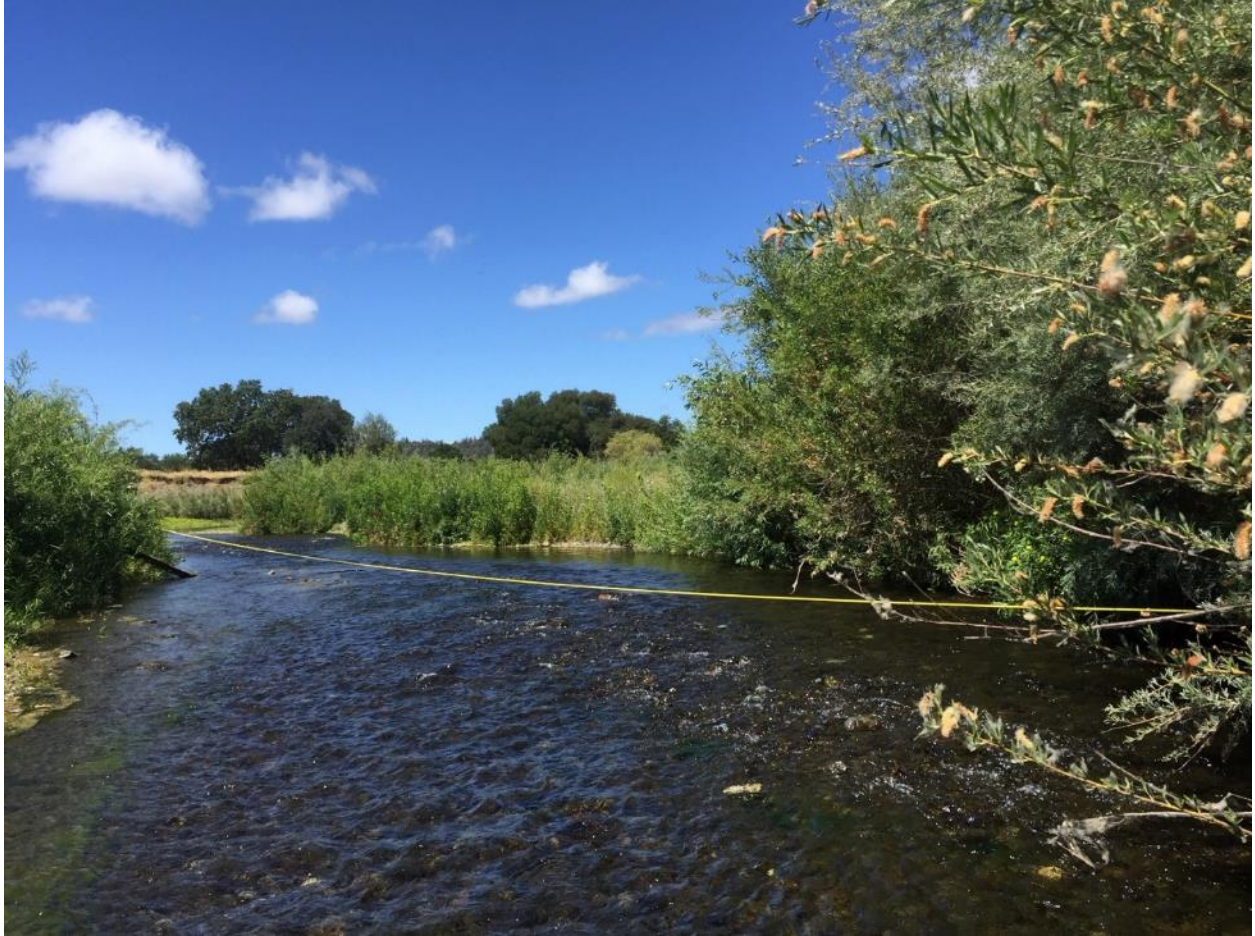
Figure A 6. A photo taken at the Geyserville sample site on the mainstem Russian River (rkm 89.04) taken on June 13, 2021 when flow was 53 cfs. Discharge is from the USGS Geyserville stream gage (gage number 11463500).

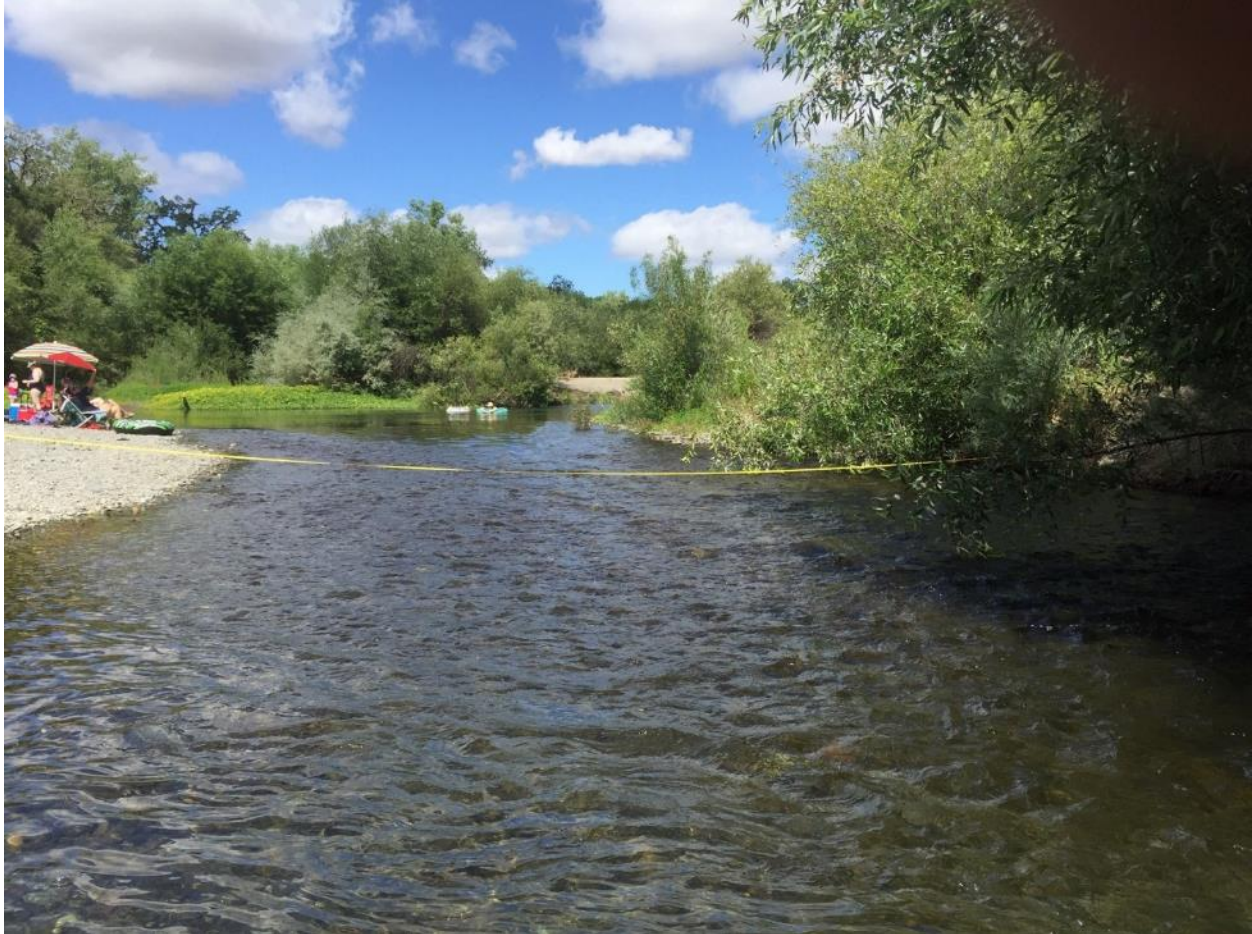
Figure A 7. A photo of the Jimtown sample site on the mainstem Russian River (rkm 77.90) taken on June 13, 2021 when flow was 38 cfs. Discharge is from the USGS Jimtown stream gage (gage number 1163682).

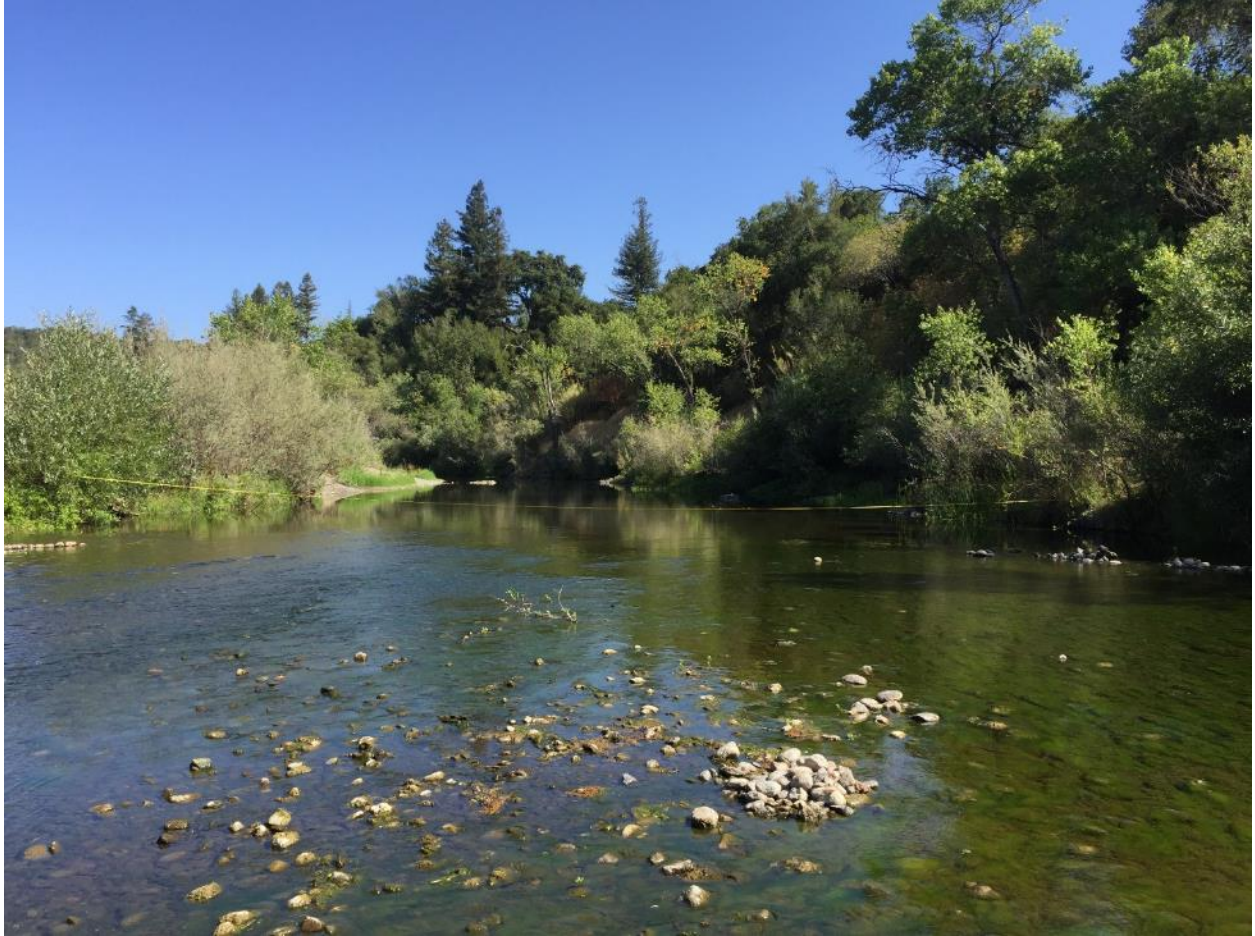
Figure A 8. A photo of the Del Rio Woods sample site on the mainstem Russian River (rkm 57.86) taken on July 12, 2021 when flow was 27 cfs. Discharge is from the USGS Digger Bend stream gage (gage number 11463980).

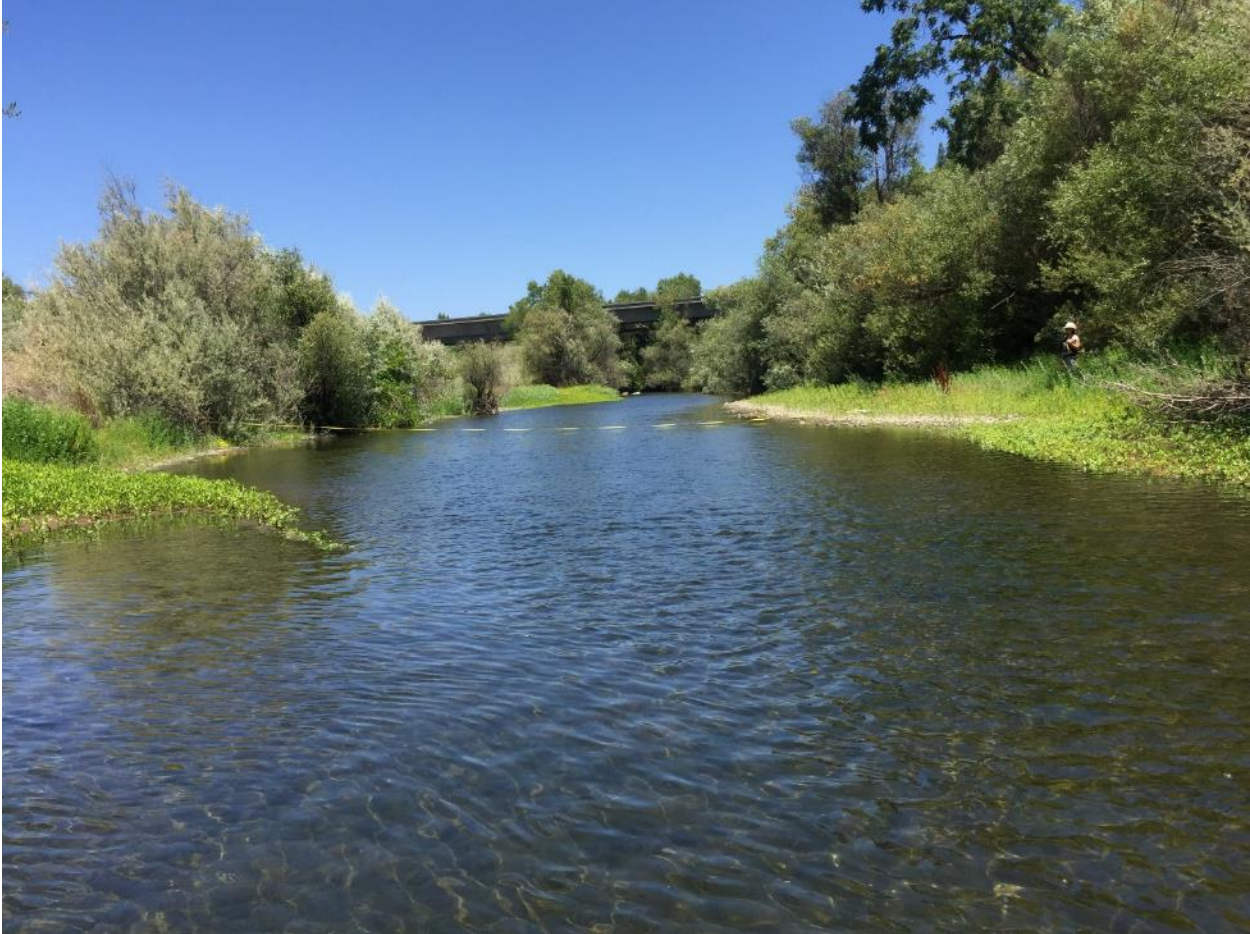
Figure A 9. A photo of the Healdsburg sample site on the mainstem Russian River (rkm 53.08) taken on July 12, 2021 when flow was 27 cfs. Discharge is from the USGS Healdsburg stream gage (gage number 11465350).

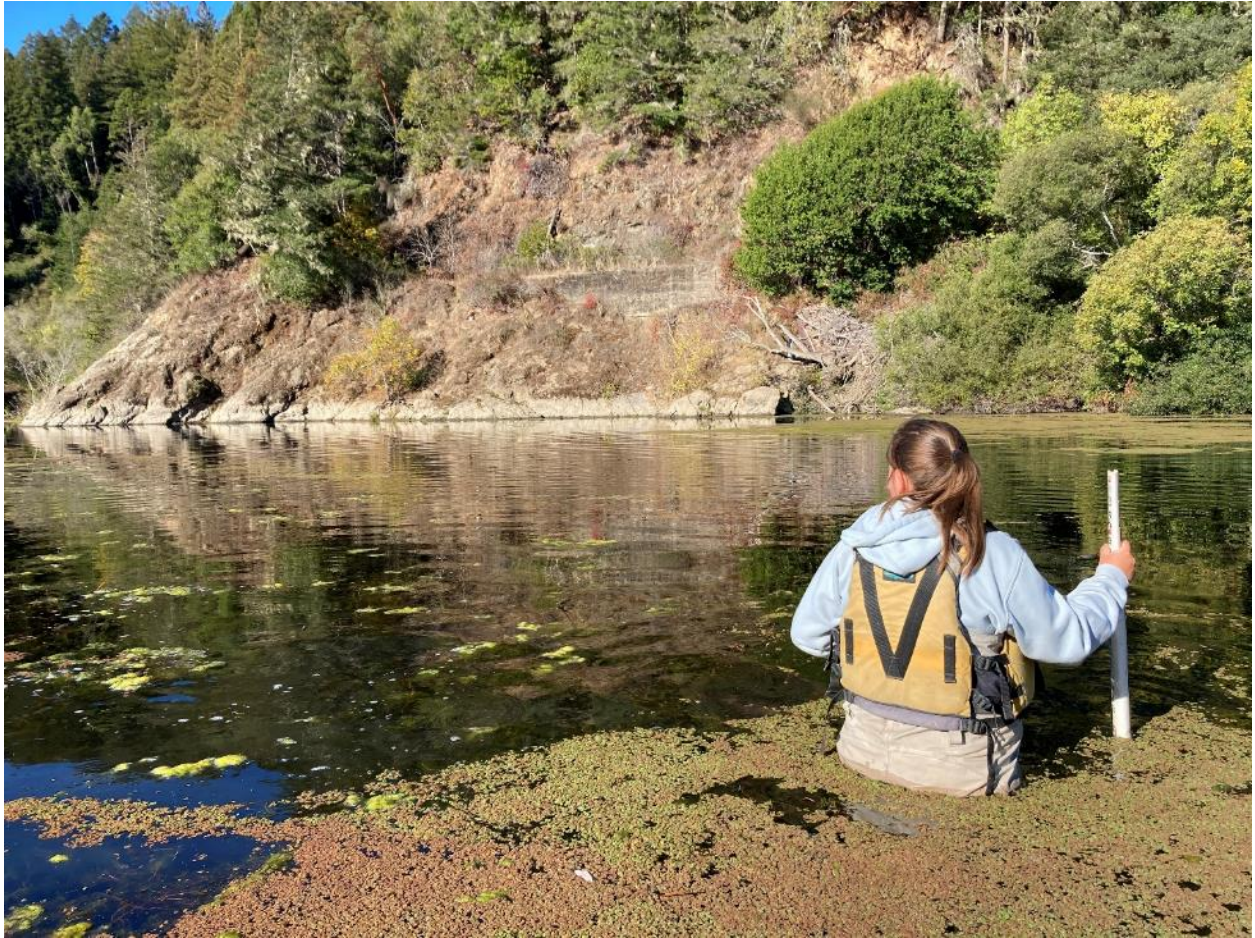
Figure A 10. Brown's riffle located near the confluence with Austin Creek on September 30, 2021 showing inundation from the ponding effect when the mouth of the Russian River closed. Flow at the USGS Hacienda stream gage (gage number 11467000) was 45 cfs.

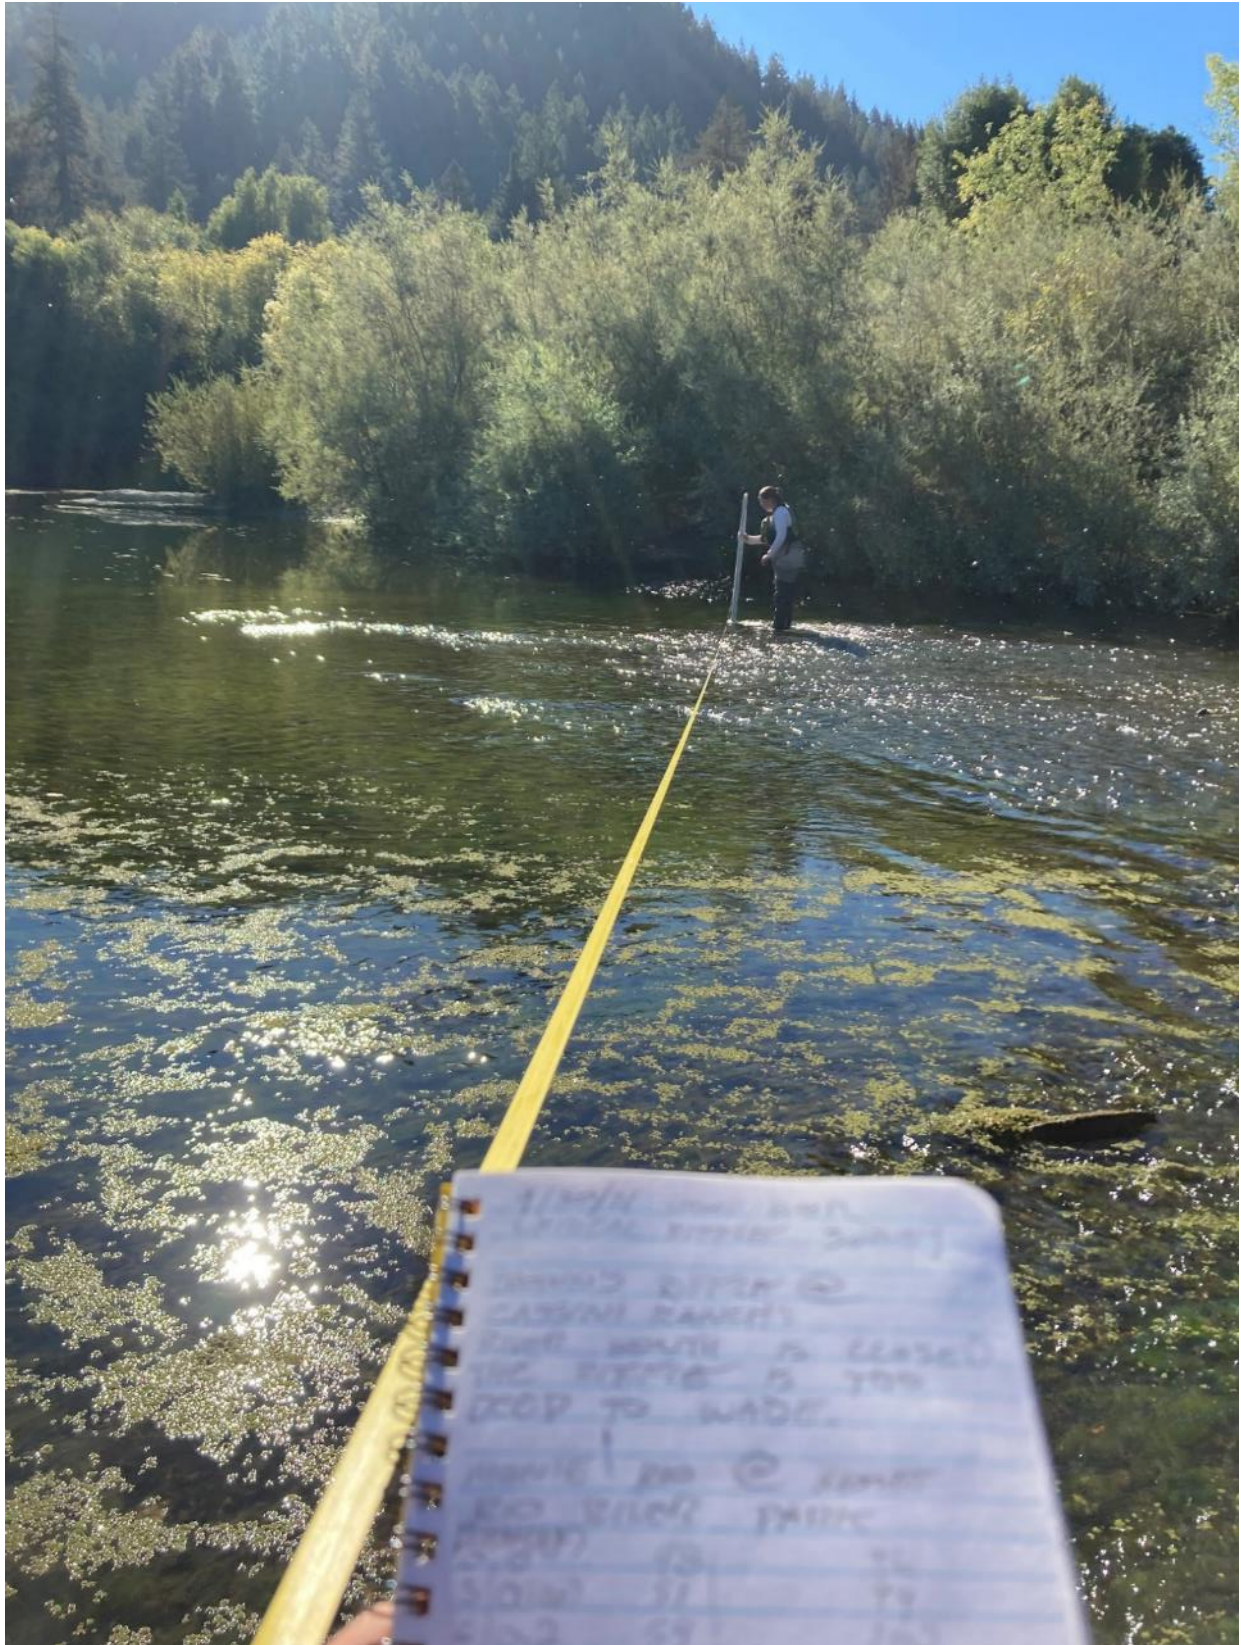
Figure A 11. A photo of the Monte Rio riffle crest cross section taken on September 30, 2021.

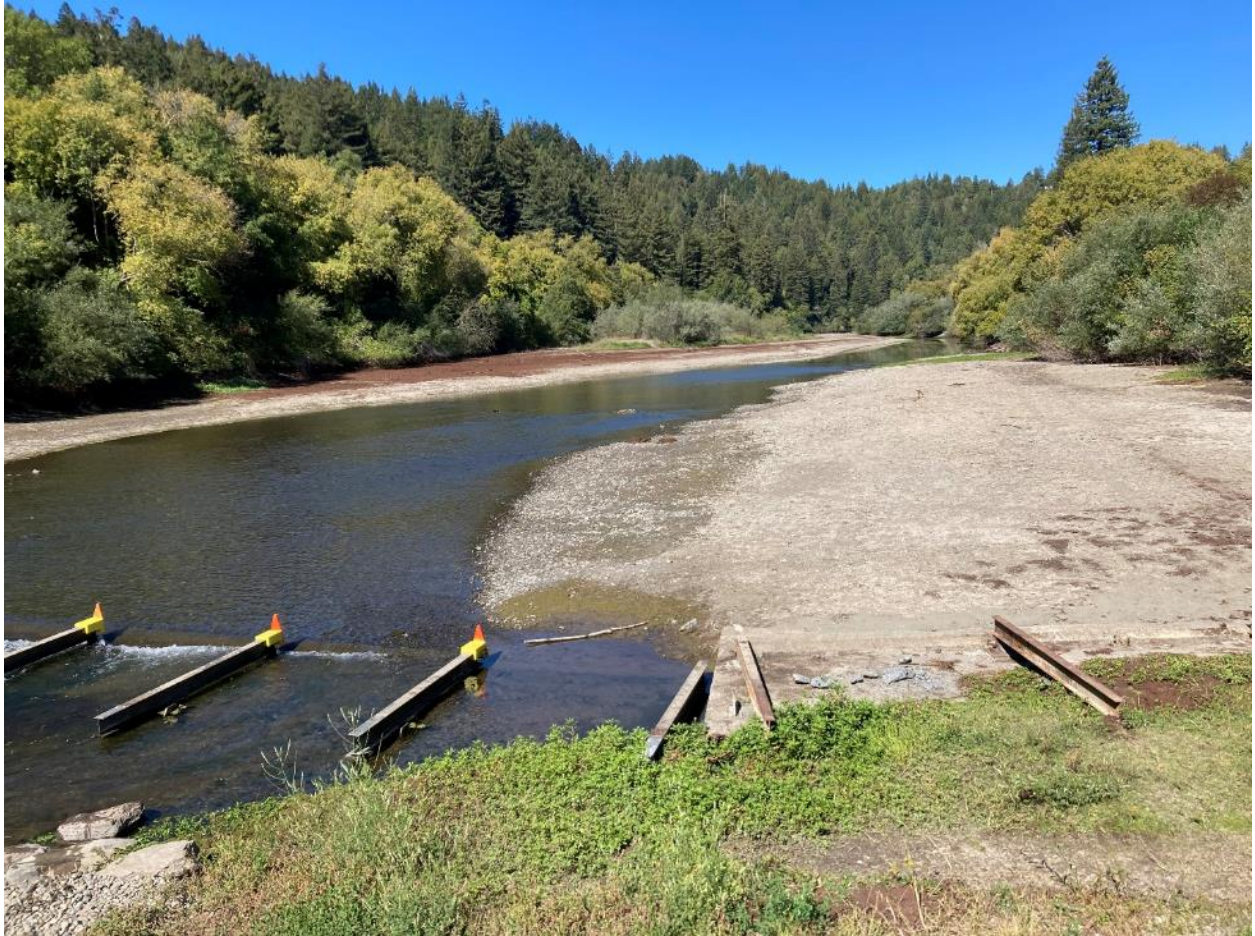
Figure A 12. Looking upstream from the Vacation Beach temporary crossing on September 30, 2021.

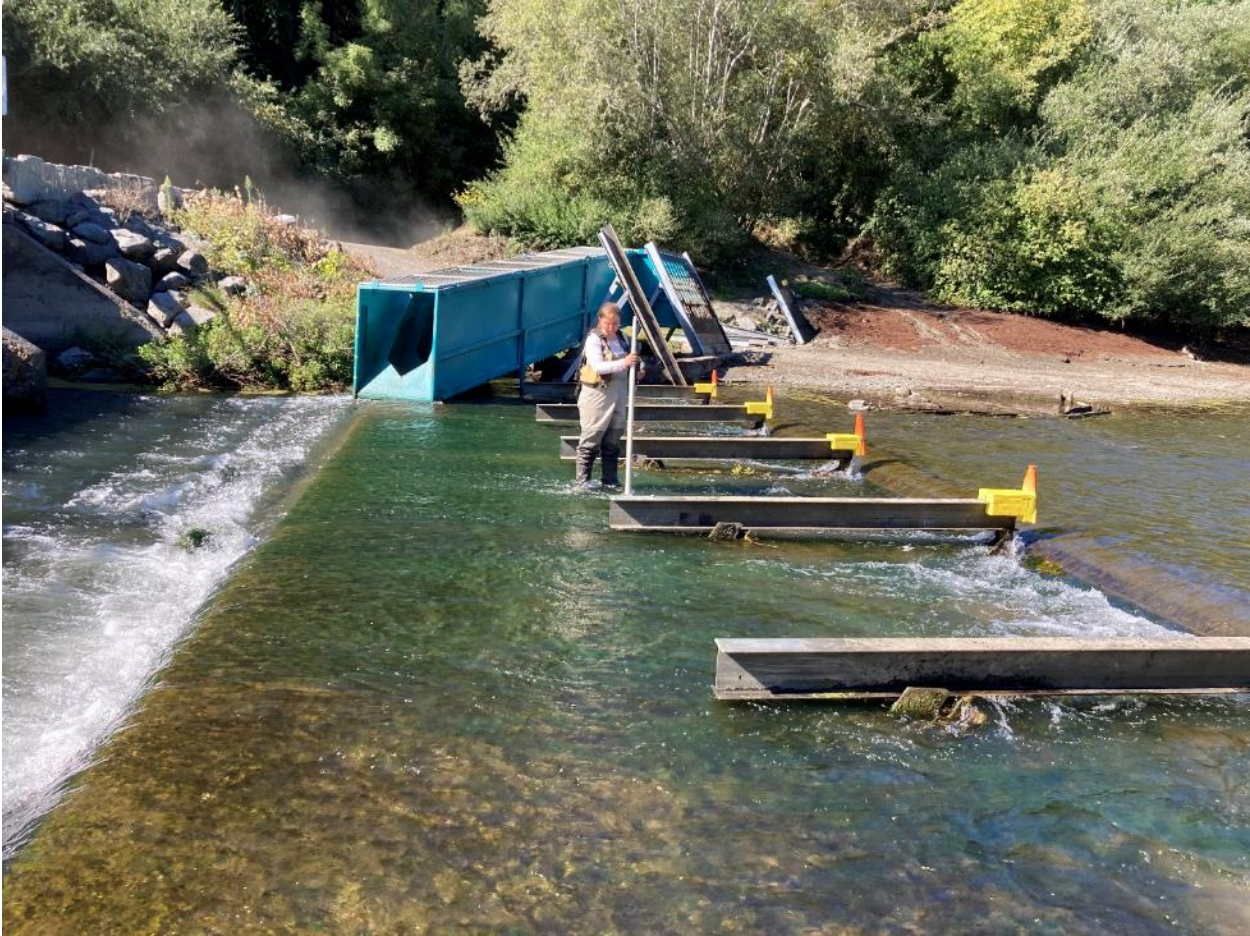
Figure A 13. Looking across the Vacation Beach dam sill on September 30, 2021.

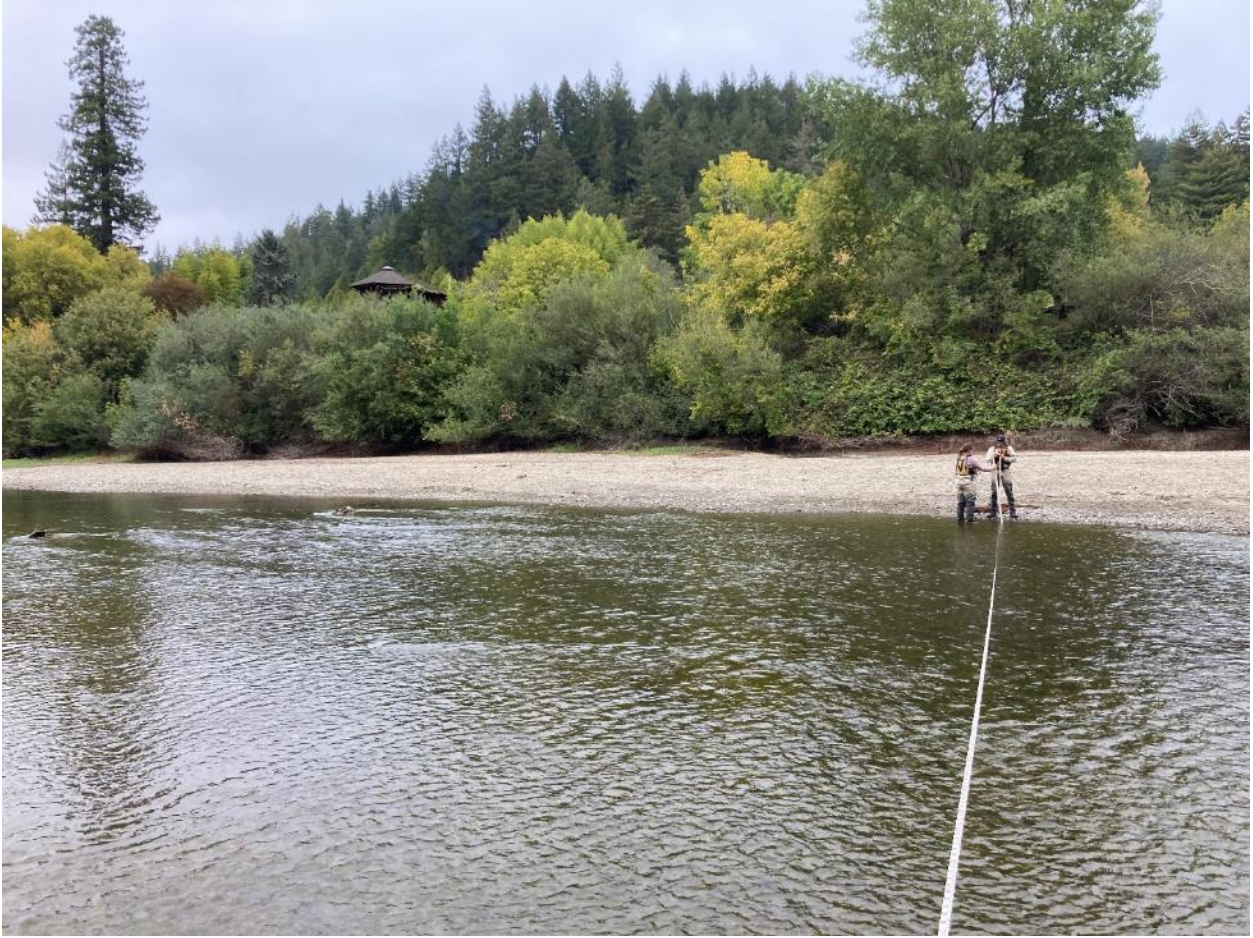
Figure A 14. A photo of the riffle crest transect taken at Vacation Beach on October 5, 2021

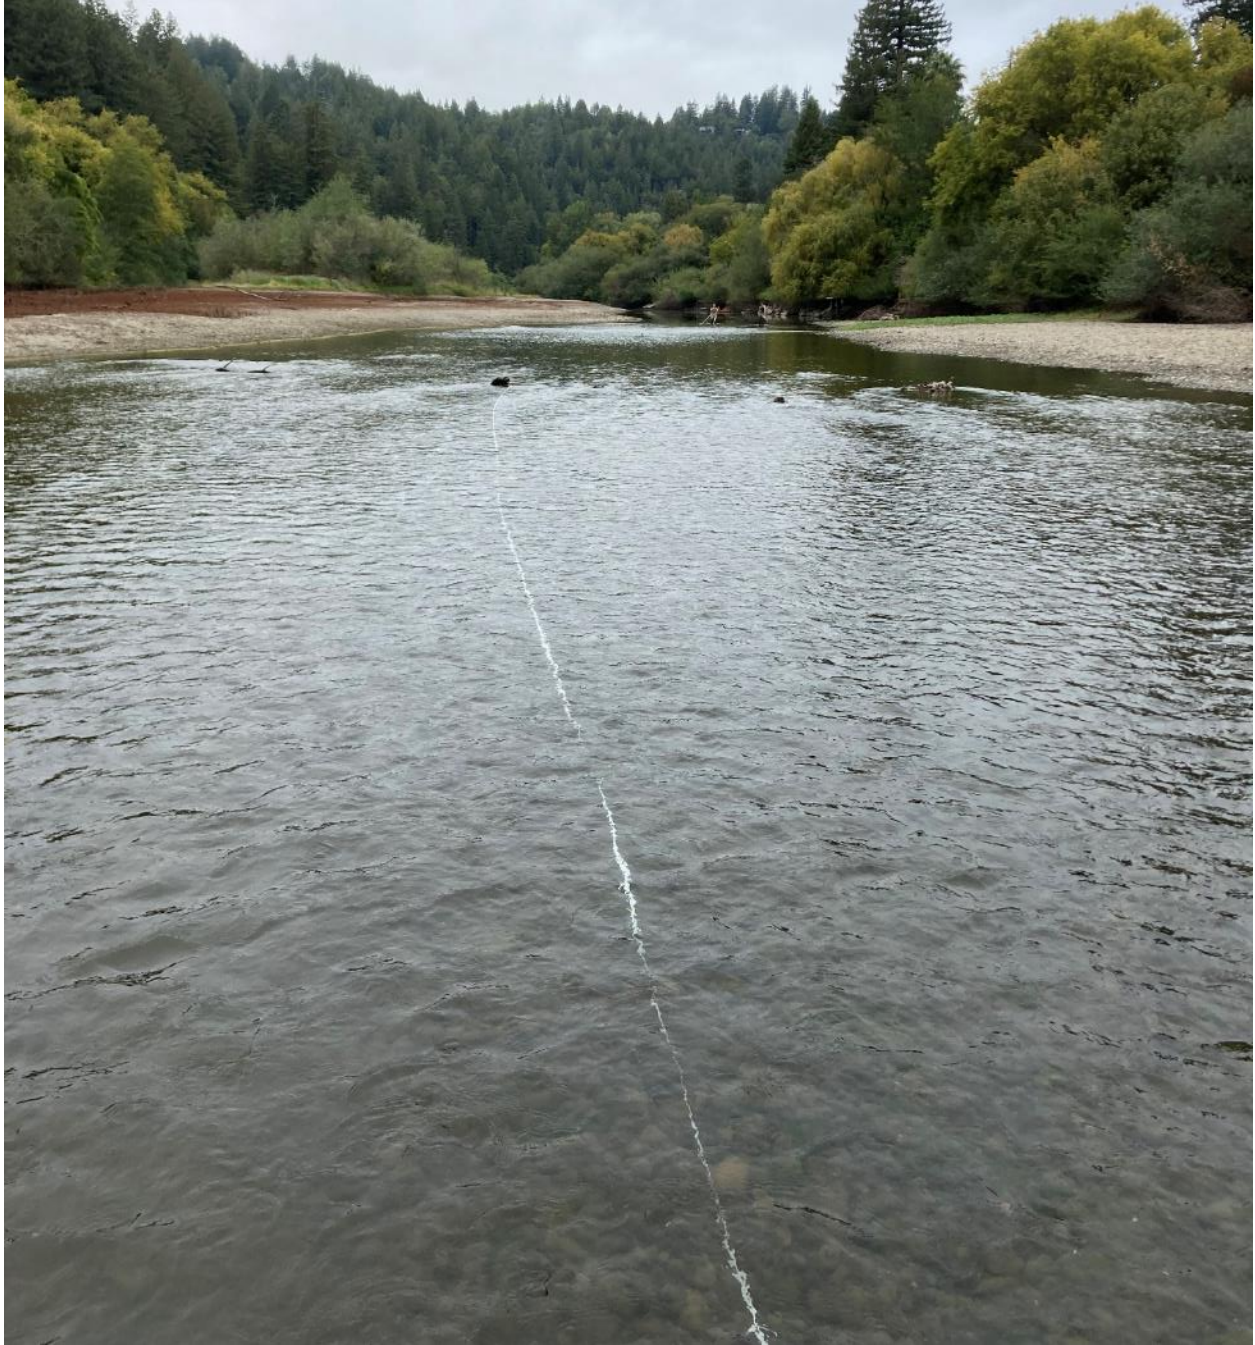
Figure A 15. A photo of the longitudinal profile taken at Vacation Beach on October 10, 2021.

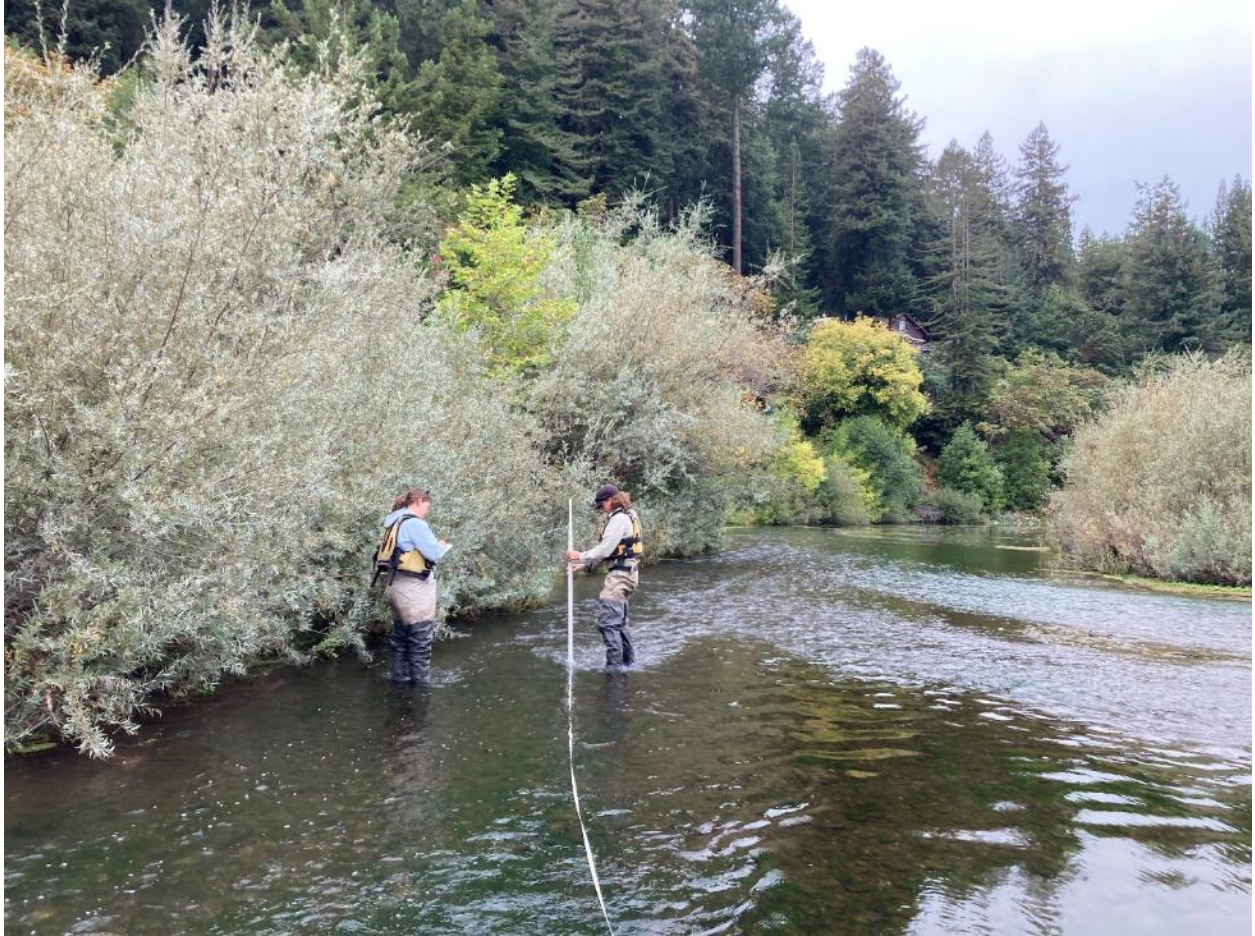
Figure A 16. A photo of the longitudinal profile taken at Monte Rio on October 10, 2021.
