**RE: Reporting Requirements for Term 7 of the State Water Resources Control Board
Order 2021-0056-EXEC (June 14, 2021)**

Term 7 - Fisheries Monitoring Summary Report

April 8, 2022

Sonoma County Water Agency

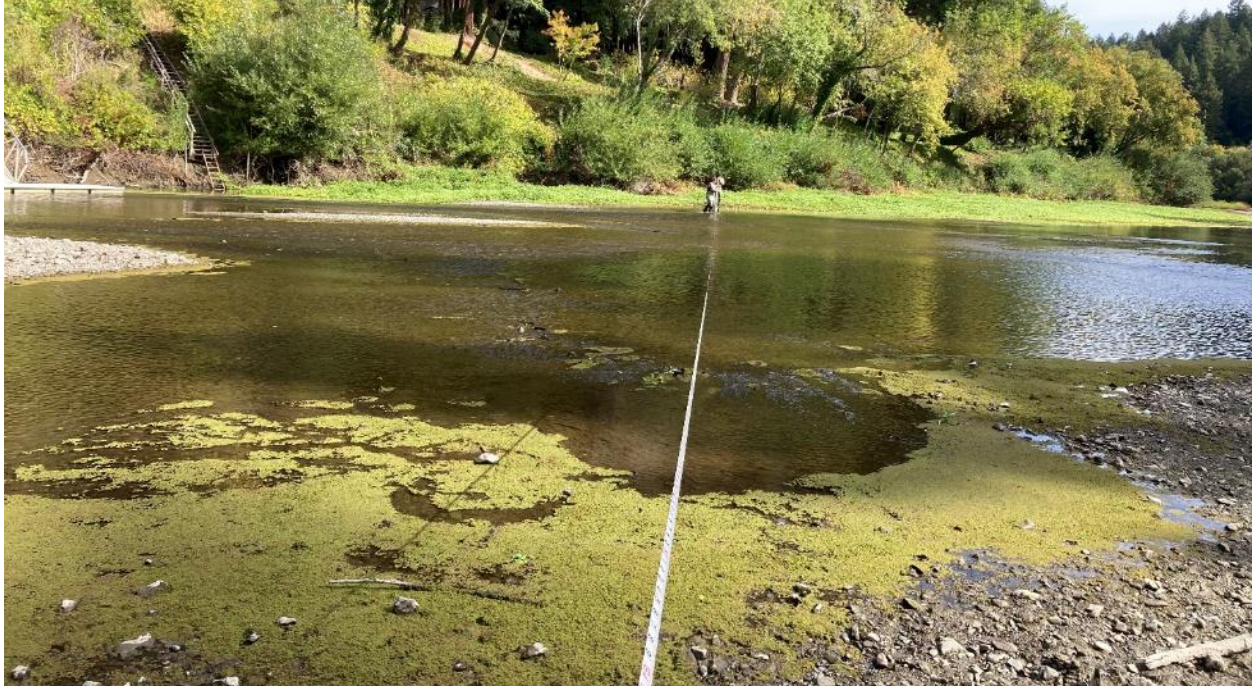
Figure A 17. A photo of the riffle crest transect taken on the Russian River near the confluence with Hulbert Creek on October 5, 2021.

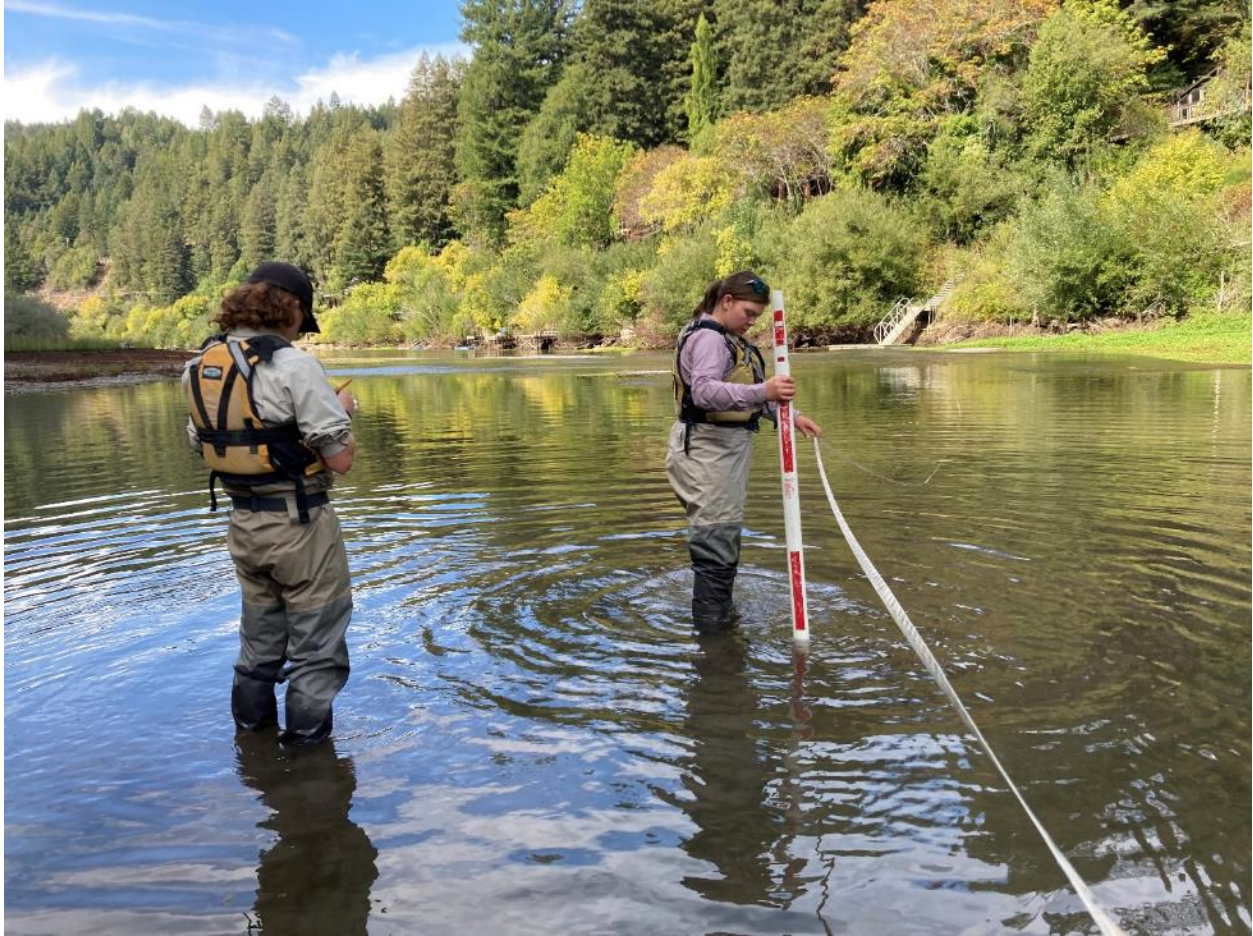
Figure A 18. A photo of the longitudinal profile taken the Russian River near the confluence with Hulbert Creek on October 10, 2021.

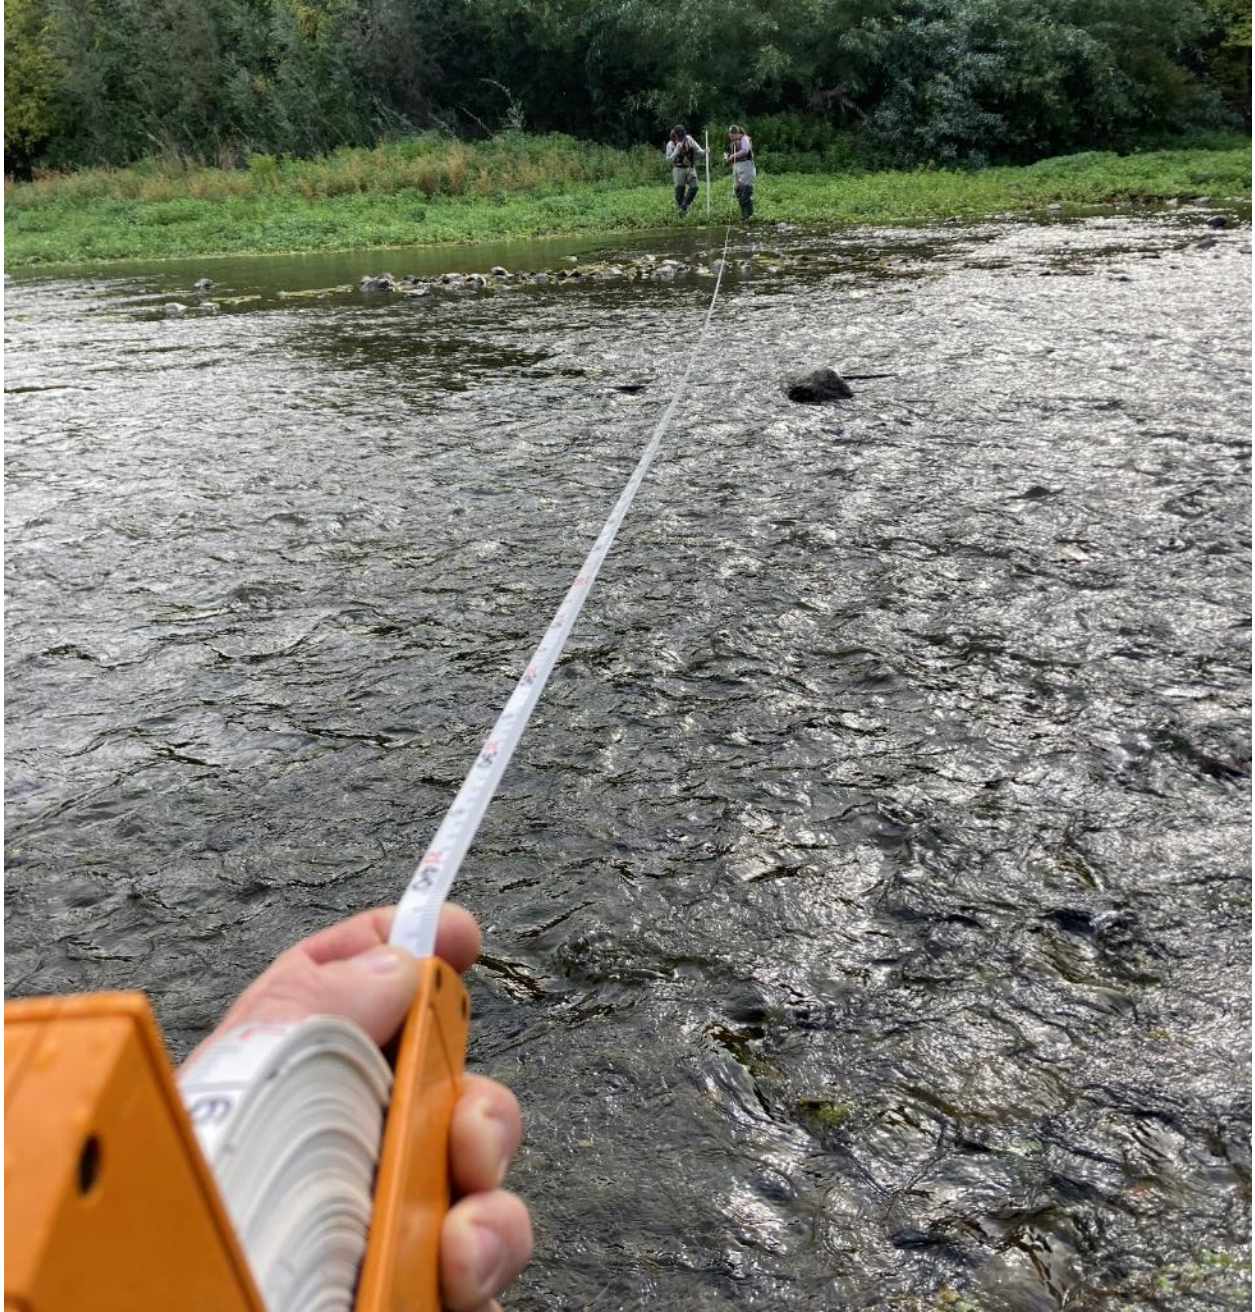
Figure A 19. A photo of the riffle crest transect taken at Summer Crossing Road on October 5, 2021.

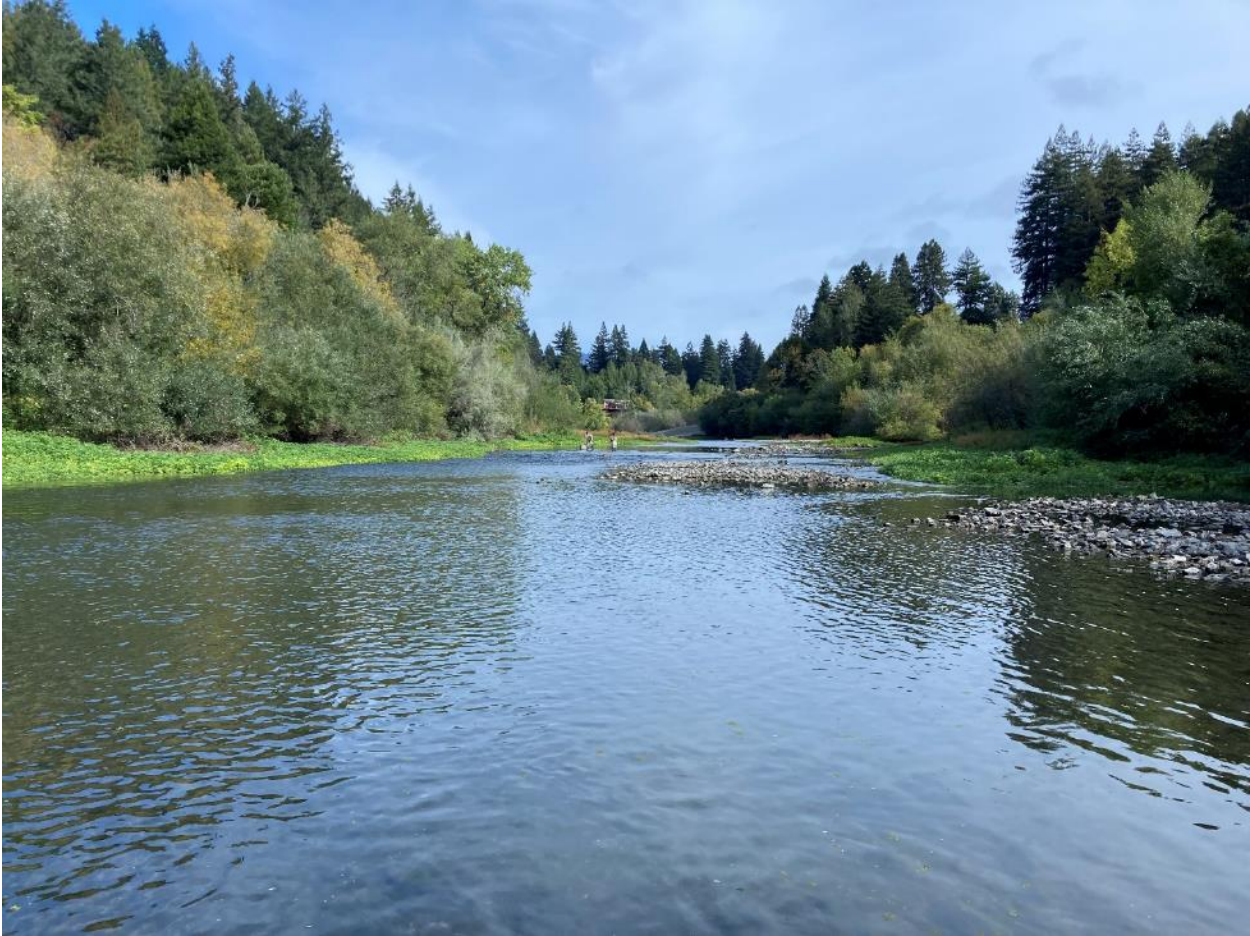
Figure A 20. A photo of the longitudinal profile taken at Summer Crossing Road on October 10, 2021.

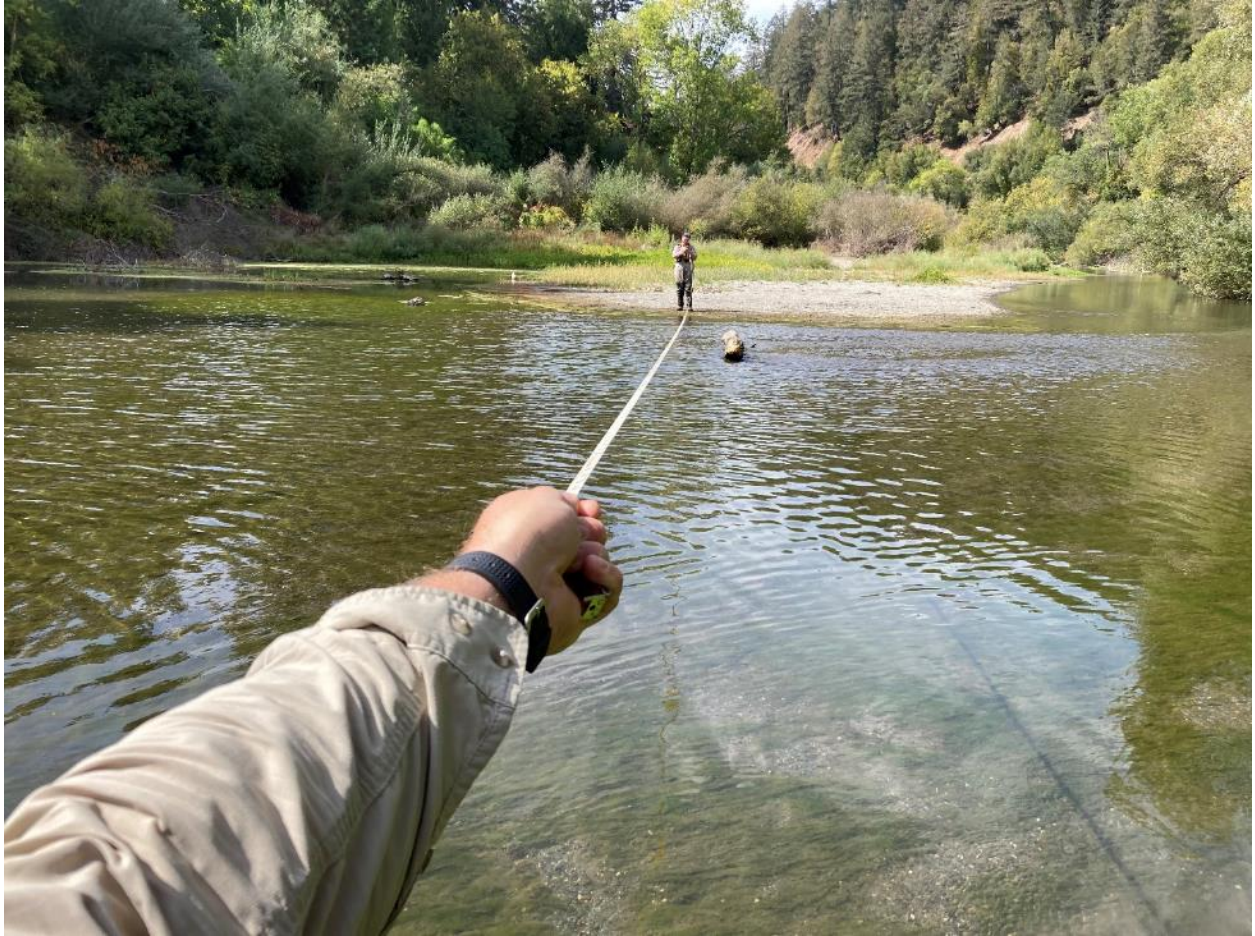
Figure A 21. A photo of the riffle crest transect taken at Mom's Beach on October 5, 2021.

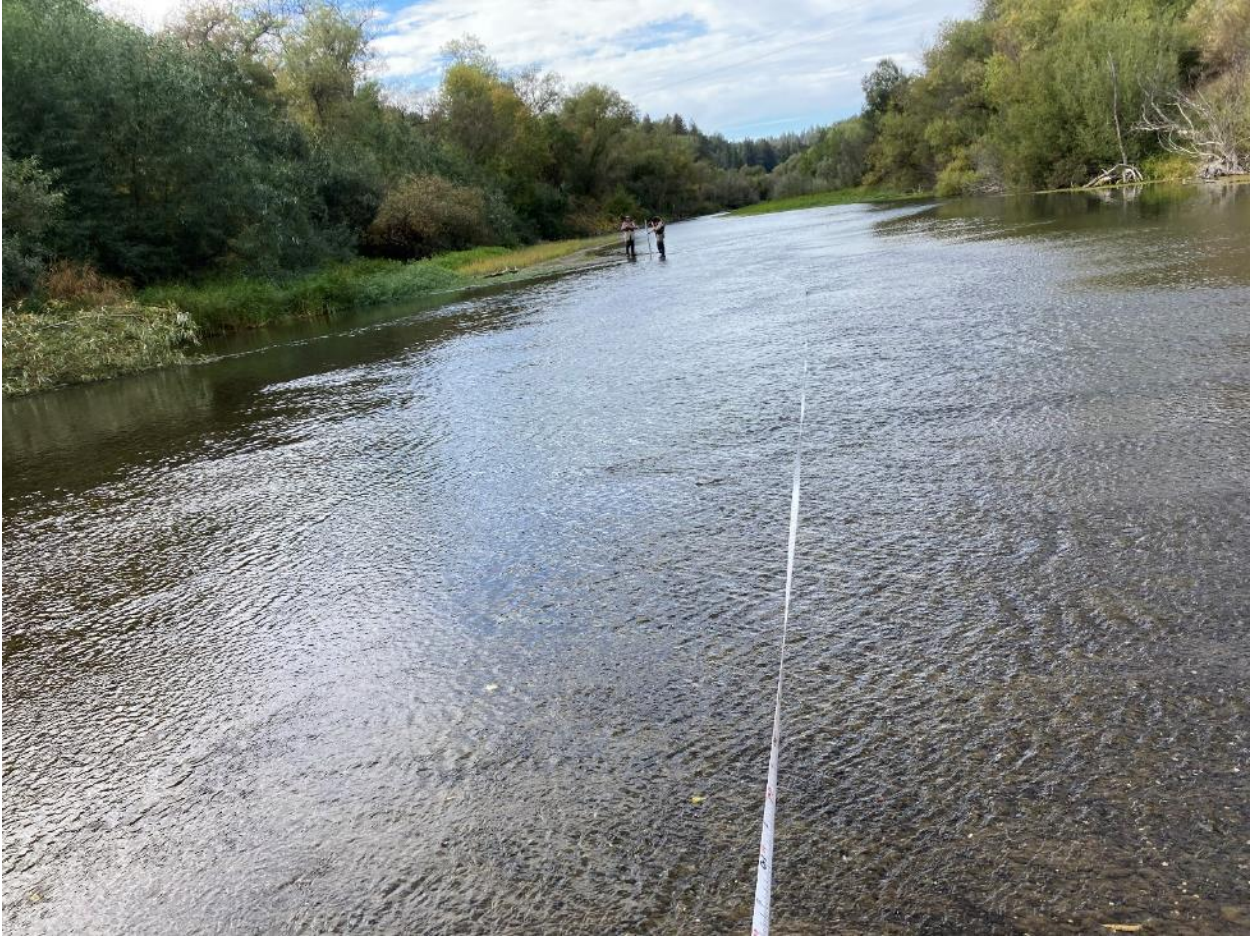
Figure A 22. A photo of the riffle crest transect taken at Steelhead beach on October 5, 2021.

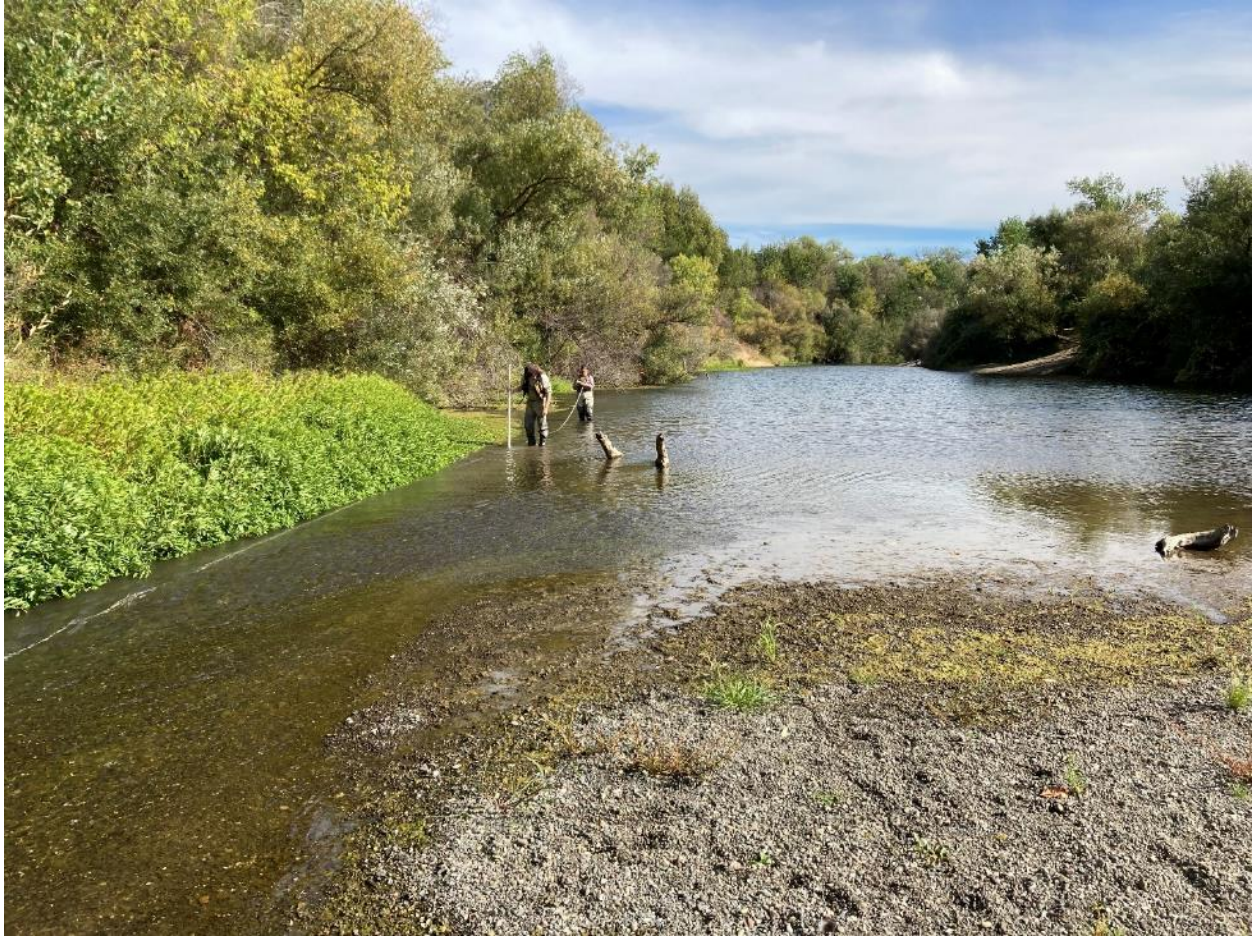
Figure A 23. A photo of the longitudinal profile taken at Steelhead Beach on October 10, 2021.
