## Term 2 and Term 4- Fisheries Monitoring Tasks

**Sonoma  
Water**

**December 1, 2022**

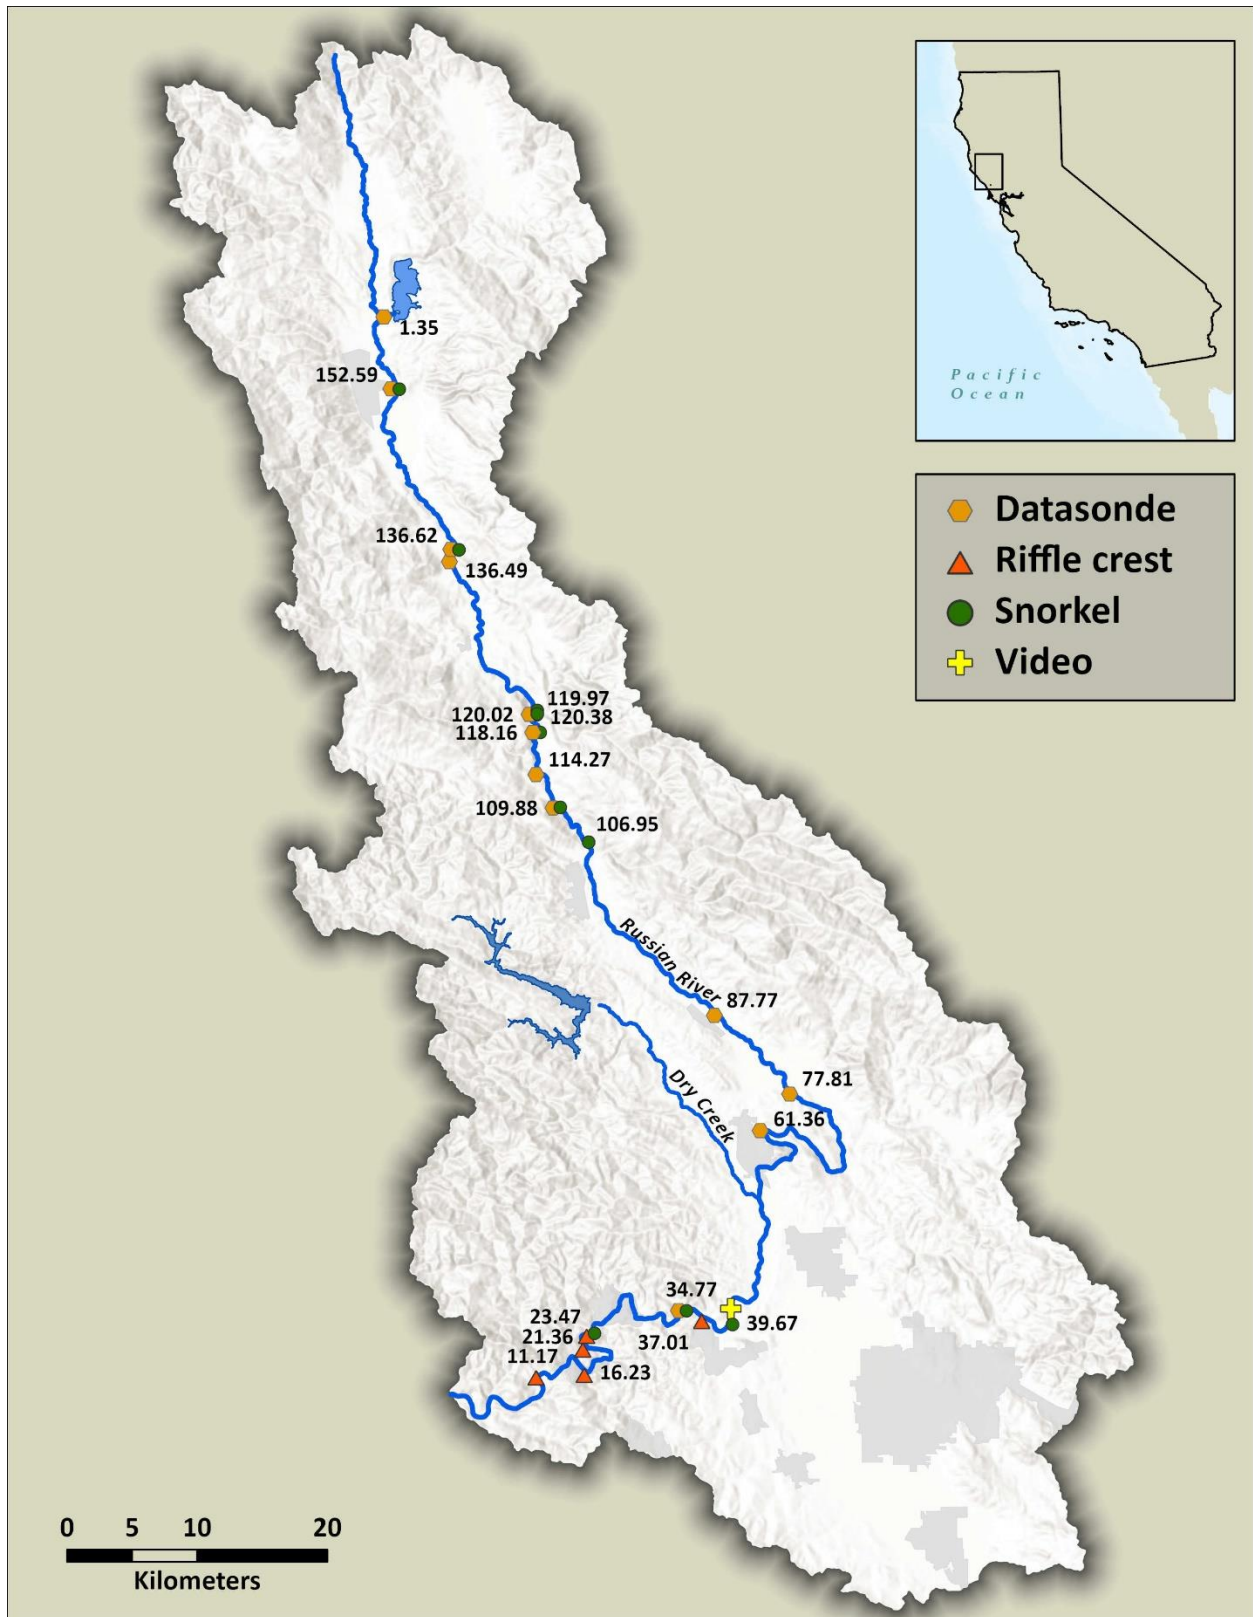
Figure 1. Sample sites for the fisheries monitoring terms in the State Water Resources Control Board 2022 Order.

In the sections that follow, we outline the monitoring methods required under Terms 2 and 4 (Fisheries Monitoring) of the Order (SWRCB 2022a). The location of sample sites and their respective river Km can be found in Figure 1 and Table 1.

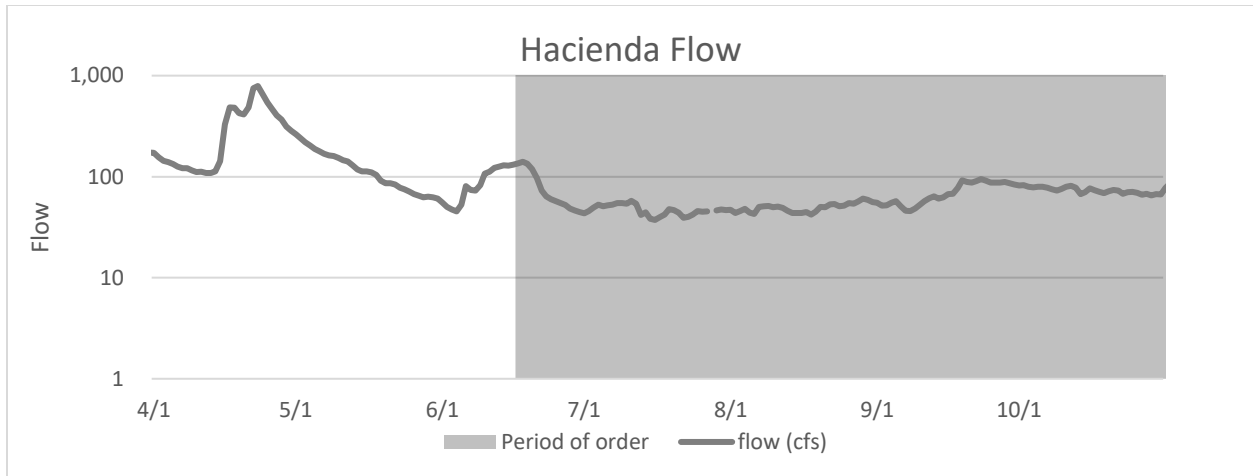
Figure 1. Flow in cubic feet per second (cfs) in the Russian River at the U.S. Geological Survey Hacienda stream gage (USGS gage number 11467000) from June 17, 2022, to October 31, 2022. Gray indicates the period included in the TUC Order issued by the State Water Resources Control Board on June 17, 2022.

This report is due before the Order expires (due on December 1, 2022) and presents data that has been collected through October 31, 2022. From June 17, 2022, when the Order went into effect, to October 31, 2022, flow at the Russian River USGS gage at Hacienda (USGS gage number 11467000) was typically under 100 cfs (Figure 1).

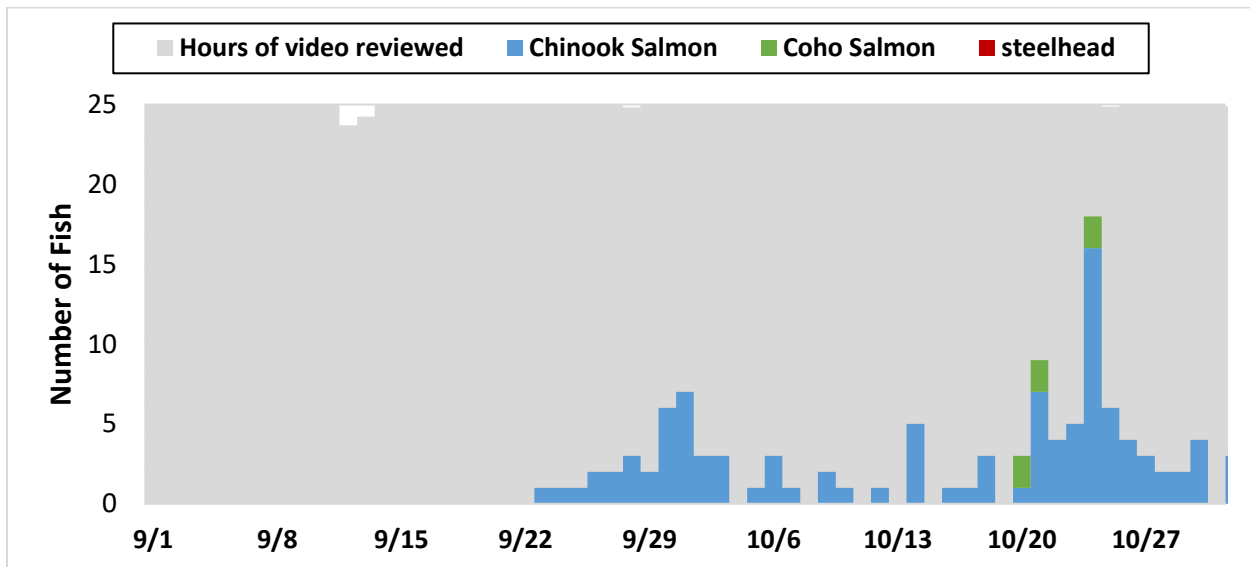
Figure 2. Number of adult salmonids and proportion of each day reviewed for video monitoring data collected at the Mirabel Dam, (9/1/2022-10/31/22).

Sonoma Water installed a video camera in the fish ladder at the Mirabel Dam on September 1, 2022, to monitor adult salmonids as they returned to the Russian River. By October 31, 2022, a total of 104 adult Chinook salmon, and 6 adult Coho had passed the Mirabel Dam (Figure 2 and Table 4).

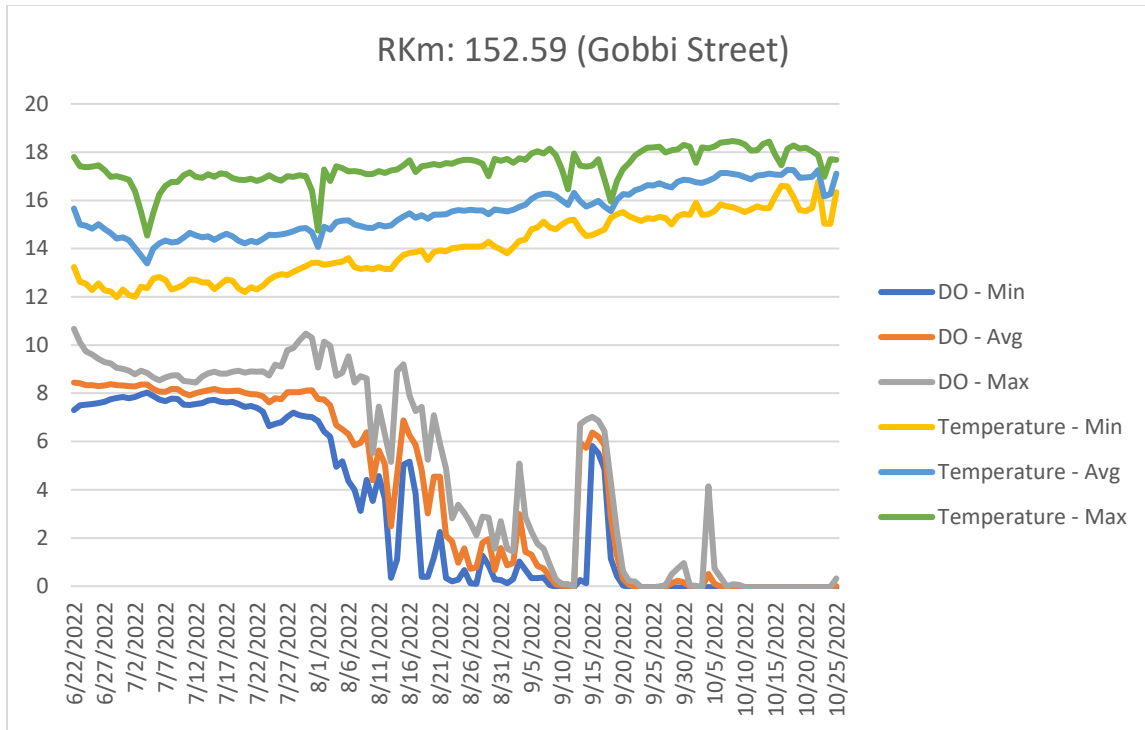
Figure 3. Temperature and dissolved oxygen collected in the mainstem Russian River near the end of Gobbi Street in Ukiah at river km 152.59 from June 22, 2022, to October 25, 2022.

Low dissolved oxygen levels at Gobbi Street may be related to conditions in Lake Mendocino but there is a possibility that the placement of the D.O. logger near the stream bottom affected the accuracy of its readings. Cool water releases made from the bottom of Lake Mendocino provide summer steelhead rearing habitat in the upper Russian River in most years. Dissolved oxygen is typically low in the east fork Russian River and generally recovers a short distance downstream (SCWA unpublished data). In 2022 dissolved oxygen in the east fork of the Russian River (6.8 rKm upstream of Gobbi Street) was also low (Figure 8). However, D.O. became low in the east fork Russian River approximately 2 months before D.O. became low at Gobbi Street. This suggests that the D.O. readings at Gobbi Street may not be related to low D.O. water released from Lake Mendocino. The pool at Gobbi Street that the logger was placed in was not stratified, but the logger was located near detritus on the stream bottom so it is possible that this decomposing material affected the D.O. measurements.

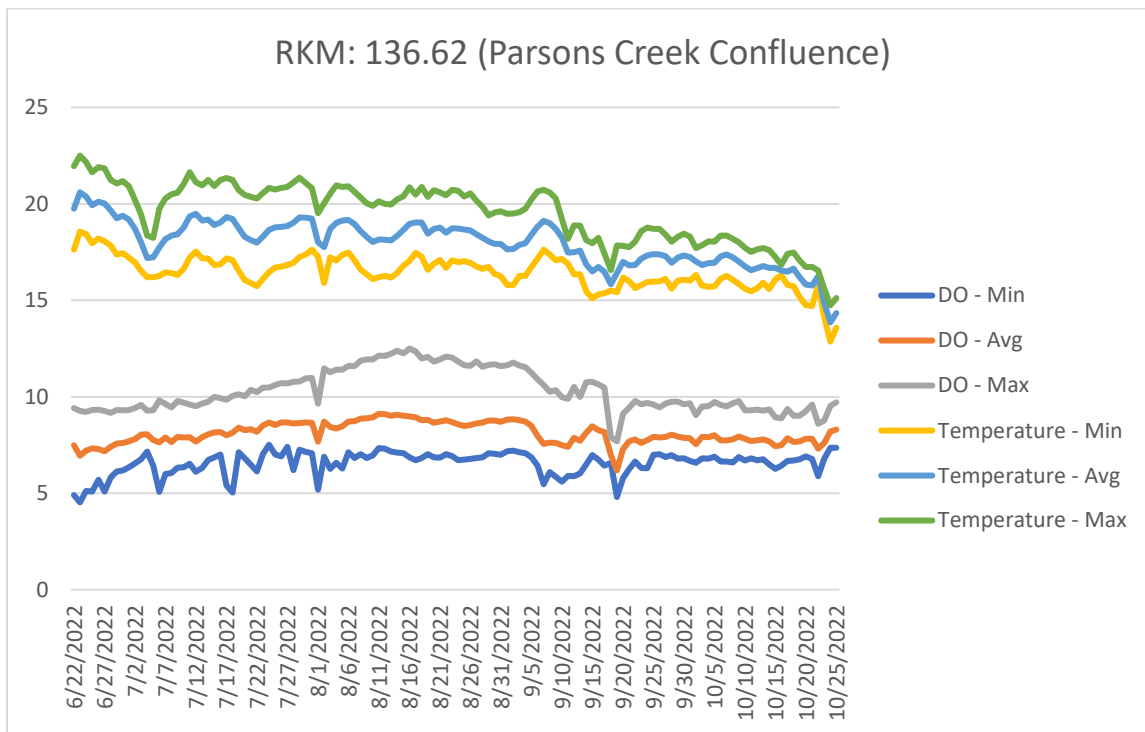
Figure 4. Temperature and dissolved oxygen collected in the mainstem Russian River near the confluence with Parsons Creek near Hopland at river km 136.62 from June 22, 2022, to October 25, 2022.

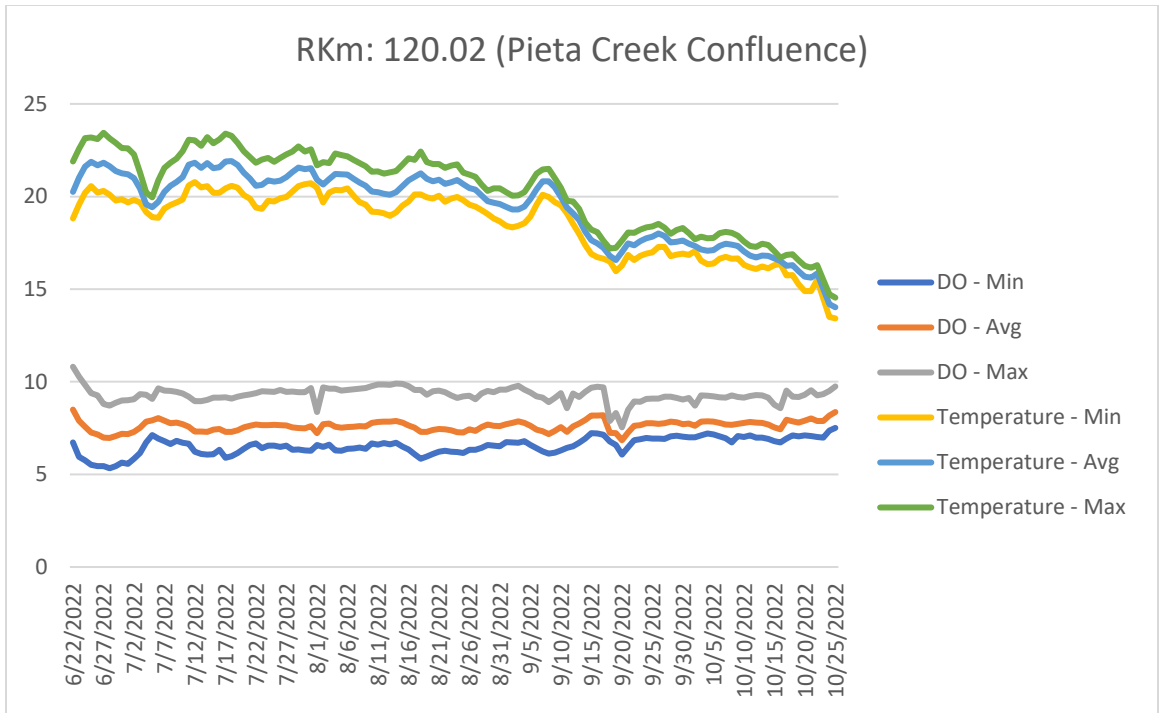
Figure 5. Temperature and dissolved oxygen collected in the mainstem Russian River near the confluence with Pieta Creek near Hopland at river km 120.02 from June 22, 2022, to October 25, 2022.

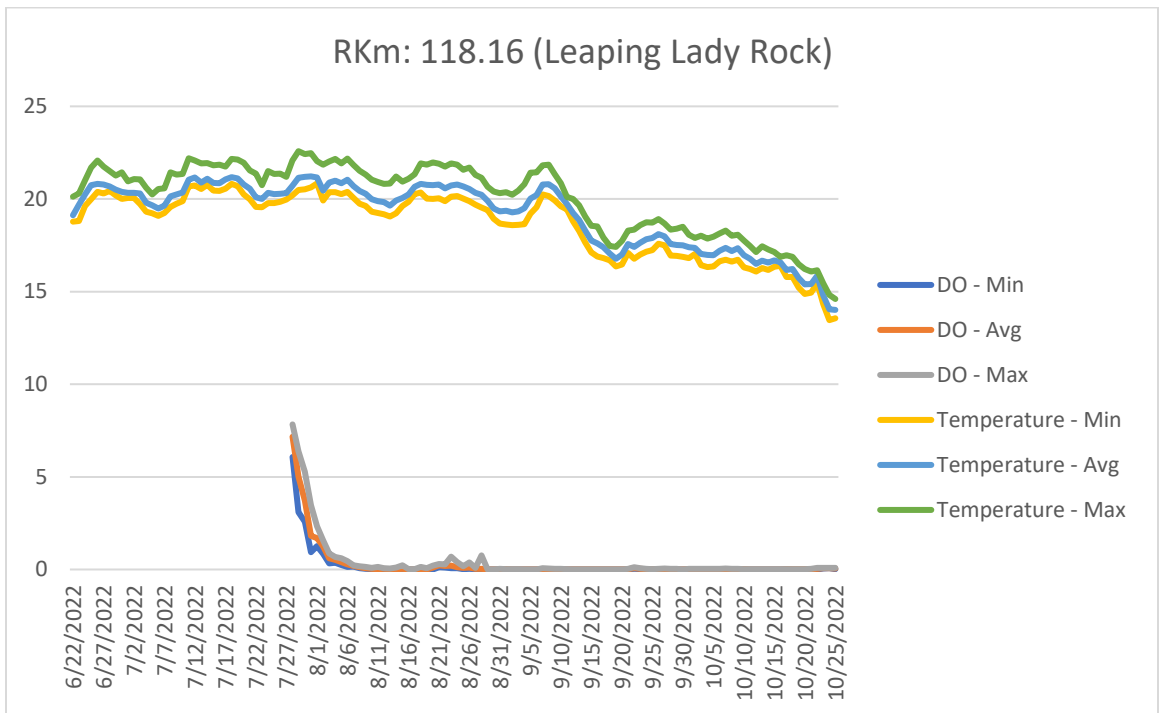
Figure 6. Temperature and dissolved oxygen (D.O.) collected in the mainstem Russian River near Leaping Lady Rock near Hopland at river km 118.16. Temperature data was collected from June 22, 2022, to October 24, 2022. The D.O. was collected from July 29, 2022, to October 25, 2022.

Temperature and dissolved oxygen loggers were recovered on October 25, 2022; however, the loggers located at the Highway 101 crossing near Geysers Road was stolen before data could be downloaded. Temperature at Gobbi Street ranged from 11.9 °C to 18.5 °C, temperature at the confluence with Parsons Creek ranged from 12.9 °C to 22.5 °C, temperature at the confluence with Pieta Creek ranged from 13.4 °C to 23.4 °C, temperature at Leaping Lady Rock ranged from 13.5 °C to 22.6 °C (Figure 3 to Figure 6). Dissolved oxygen at Gobbi Street was poor after mid-August, dissolved oxygen at Parsons Creek and at Pieta Creek was fair (Figure 3 to Figure 6). The dissolved oxygen sensor for Leaping Lady Rock was being serviced and could not be installed until late July. It was installed on the stream bottomed at the bottom of a deep pool. After the D.O. logger was installed at Leaping Lady Rock D.O. declined sharply (Figure 6).

D.O. at Leaping Lady Rock was lower than D.O. at the confluence of the mainstem Russian River with Pieta Creek and the confluence of the mainstem Russian River with Parson Creek. This is likely due to thermal stratification occurring in the pool at Leaping Lady Rock resulting in limited oxygen exchange with the hypolimnion. In 2021 the pool at Leaping Lady Rock was thermally stratified whereas the pools at the confluence of the mainstem Russian River with Pieta Creek and the confluence of the mainstem Russian River with Parson Creek were not thermally stratified. Thermal stratification in pools was not an environmental condition that was monitored in 2022. However, because flows in summer 2022 were similar to those in 2021, it is likely that stratification occurred at Leaping Lady Rock in 2022.

Unfortunately, the cooler water at the bottom of Leaping Lady Rock pool may not have been valuable rearing habitat as dissolved oxygen at the bottom of the pool was low (Figure 6).

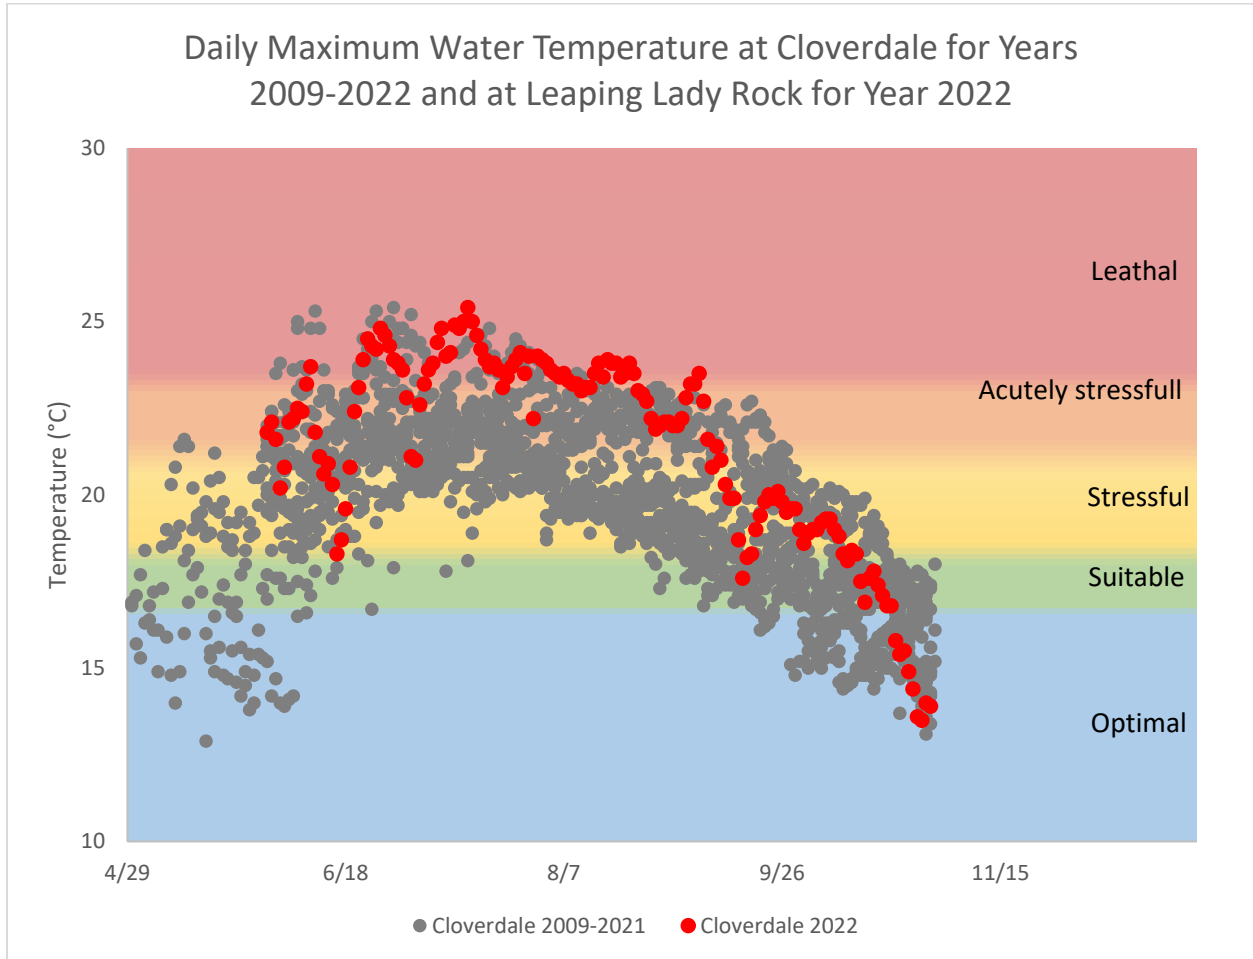
Figure 7. The daily maximum water temperatures for years 2009 through 2022 from the USGS Russian River gage at Cloverdale (USGS gage number 11463000) shown with optimal ( $< 16.9^\circ\text{C}$ ), suitable ( $16.9^\circ\text{C}$  to  $18.9^\circ\text{C}$ ), stressful ( $18.9^\circ\text{C}$  to  $21.9^\circ\text{C}$ ), acutely stressful ( $21.9^\circ\text{C}$  to  $23.8^\circ\text{C}$ ) and lethal ( $> 23.9^\circ\text{C}$ ) water temperature zones for steelhead rearing based on SCWA 2016.

in the section of river between Hopland and Cloverdale. In 2022 water temperatures at the USGS Cloverdale gage (USGS gage number 11463000) reached unfavorable temperatures for steelhead rearing (Figure 7). However, it is worth noting that water temperatures are often acutely stressful at the Cloverdale site (Figure 7). For a detailed discussion of water temperature see Sonoma Water’s report that summarizes data collected for Term 3 (water quality) in the 2022 TUCO.

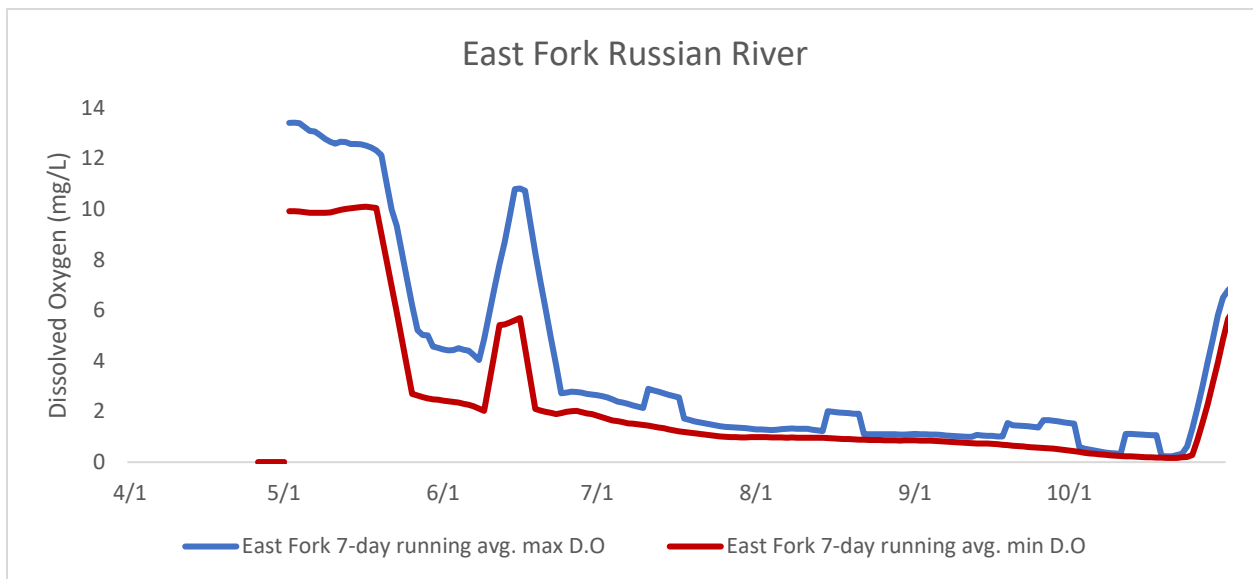
Figure 8. Dissolved oxygen in the east fork Russian River near the outlet of the Coyote Valley Dam.
